# Access Compliance Report

## Public Rights-of-Way

### (Curb Ramps)

Intersection ID: 11600	Main Street: ALLEN_ST	Cross Street: PARKWOOD_AV	Location: SE
ADA ID: 3B06FB43F05A	Ramp Type: BlendTrans1	Initial Pass/Fail: Fail	Overall Compliance: No
Severity Score: 21.25			
Codes/Mitigation Info/Possible Solution		Field Measurements/Component Compliance

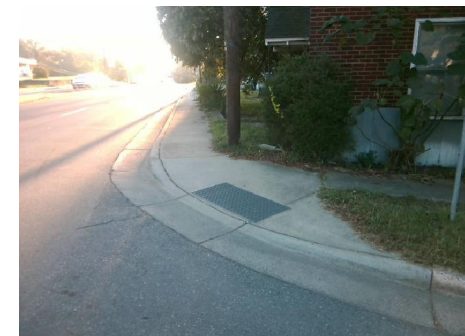
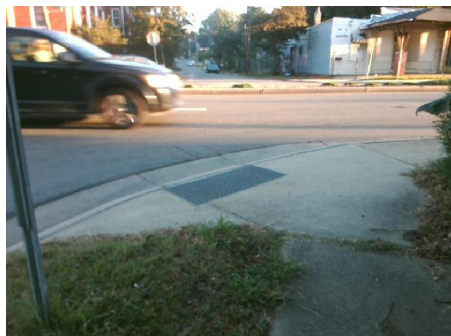
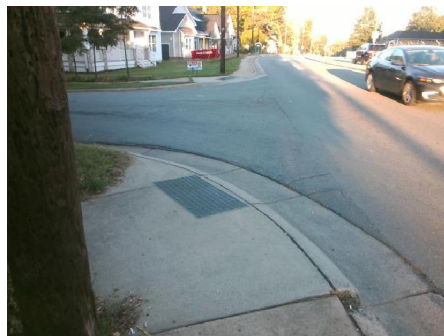
**Not Found, R304.5.1, R304.5.3**

Compliance	Description	Data	Compliance	Description	Data
N/A	Ramp Length (in)	62.0	Yes	BlendTrans Slope (%)	2.5
No	Ramp Width (in)	45.0	No	BlendTrans XSlope (%)	5.8
N/A	Flare Type LT	N/A	N/A	Flare Type RT	N/A
N/A	Flare Slope LT (%)	N/A	N/A	Flare Slope RT (%)	N/A
N/A	Flare Traversable LT?	N/A	N/A	Flare Traversable RT?	N/A
N/A	Landing Length (in)	N/A	N/A	DWS Provided?	N/A
N/A	Landing Width (in)	N/A	N/A	DWS Contrast?	N/A
N/A	Landing Slope (%)	N/A	N/A	DWS Length (in)	N/A
N/A	Landing X Slope (%)	N/A	N/A	DWS Full Width?	N/A
N/A	Landing Curb? (Y/N)	N/A	N/A	DWS Offset (in)	N/A
N/A	Shared Landing?	N/A			
N/A	Gutter Ponding?	N/A	N/A	Gutter Slope (%)	N/A
N/A	Gutter Lip Ht (in)	1.0	N/A	Gutter X Slope (%)	N/A
N/A	Painted X Walk1?	No	N/A	Painted X Walk2?	N/A
	X Walk 1 Direction	To W		X Walk 2 Direction	N/A
	X Walk 1 Width (in)	N/A		X Walk 2 Width (in)	N/A
	X Walk 1 Slope (%)	0.9		X Walk 2 Slope (%)	N/A
	X Walk 1 X Slope (%)	4.6		X Walk 2 X Slope (%)	N/A

N/A	Ramp inside XWalk1?	N/A	N/A	Ramp inside XWalk2?	N/A
	Road Slope (%)	4.6		Clear Space?	N/A
	Road X Slope (%)	0.9	N/A	Clear Space to XWalk (in)	N/A
N/A	Any Obstructions?	N/A	N/A	Storm Grate/Utility Hazard?	N/A
	Obstruction Type			Storm Grate/Utility Type	
		N/A			N/A
			Yes	Surface Condition? (G/P)	Good
			No	Curb Slope (%)	21.0

**Remove & Replace Curb Ramp With Two New Directional Ramps or Equivalent.**
