# Access Compliance Report

## Public Rights-of-Way

### (Curb Ramps)

Intersection ID: 30254	Main Street: BRADEN_DR	Cross Street: RICHWAY_CT	Location: E
ADA ID: 3B0CA3E1D493	Ramp Type: PerpDiag	Initial Pass/Fail: Fail	Overall Compliance: No
		Severity Score: 1.25

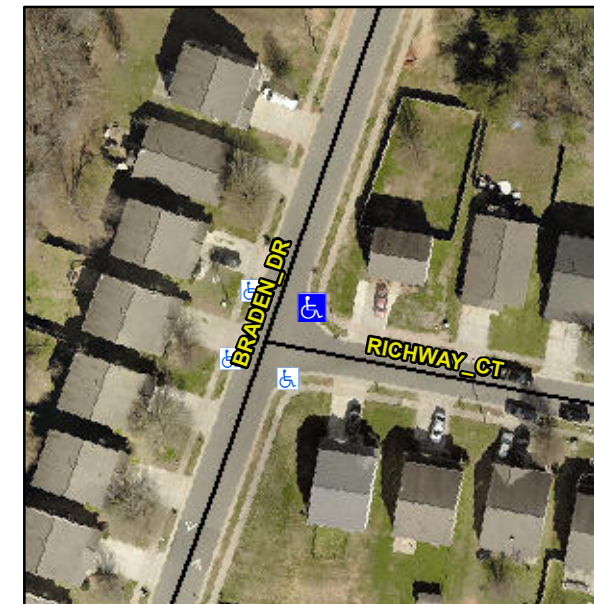
Compliance	Description	Data	Compliance	Description	Data
N/A	Ramp Length (in)	94.5	Yes	Ramp Slope (%)	7.2
Yes	Ramp Width (in)	94.5	No	Ramp XSlope (%)	4.8
N/A	Flare Type LT	N/A	N/A	Flare Type RT	N/A
N/A	Flare Slope LT (%)	N/A	N/A	Flare Slope RT (%)	N/A
N/A	Flare Traversable LT?	N/A	N/A	Flare Traversable RT?	N/A
N/A	Landing Length (in)	N/A	N/A	DWS Provided?	N/A
N/A	Landing Width (in)	N/A	N/A	DWS Contrast?	N/A
N/A	Landing Slope (%)	N/A	N/A	DWS Length (in)	N/A
N/A	Landing X Slope (%)	N/A	N/A	DWS Full Width?	N/A
N/A	Landing Curb? (Y/N)	N/A	N/A	DWS Offset (in)	N/A
N/A	Shared Landing?	N/A			
N/A	Gutter Ponding?	N/A	N/A	Gutter Slope (%)	N/A
N/A	Gutter Lip Ht (in)	N/A	N/A	Gutter X Slope (%)	N/A
N/A	Painted X Walk1?	No	N/A	Painted X Walk2?	No
	X Walk 1 Direction	To NW		X Walk 2 Direction	To SW
N/A	X Walk 1 Width (in)	N/A	N/A	X Walk 2 Width (in)	N/A
	X Walk 1 Slope (%)	3.0		X Walk 2 Slope (%)	1.1
	X Walk 1 X Slope (%)	2.1		X Walk 2 X Slope (%)	3.1

N/A	Ramp inside XWalk1?	N/A	N/A	Ramp inside XWalk2?	N/A
	Road Slope (%)	4.8	N/A	Clear Space?	N/A
	Road X Slope (%)	1.9	N/A	Clear Space to XWalk (in)	N/A
N/A	Any Obstructions?	N/A	N/A	Storm Grate/Utility Hazard?	N/A
	Obstruction Type			Storm Grate/Utility Type	
		N/A			N/A
		Yes		Surface Condition? (G/P)	Good

**Remove & Replace Curb Ramp With Two New Directional Ramps or Equivalent.**

**R304.5.3**

**\$ 3200.00**

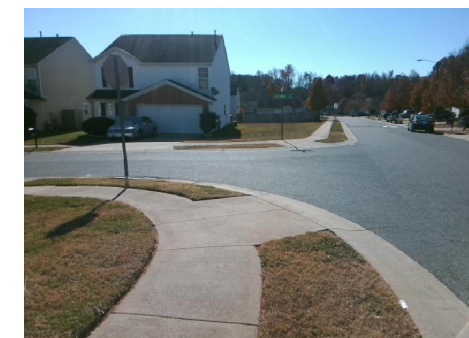
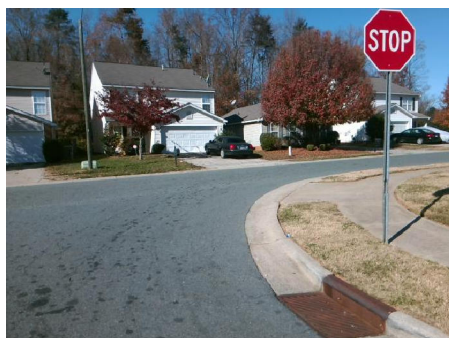
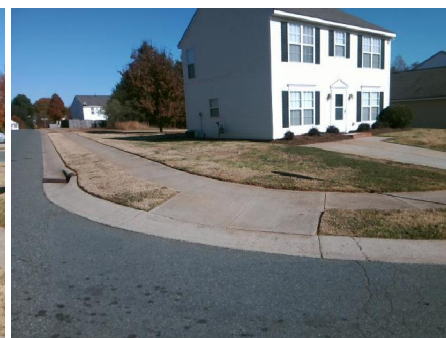
Street 1 Name **BRADEN DR**  
 Stop Condition-Street 2 **None**  
 Street 2 Name **RICHWAY CT**  
 Stop Condition-Street 1 **StopSign**
