# Access Compliance Report

## Public Rights-of-Way

### (Curb Ramps)

Intersection ID: 11457	Main Street: TRYON-CHURCH_CONNECTOR_ST	Cross Street: N_CHURCH_ST	Location: E
ADA ID: 3B10FFF06E9E	Ramp Type: Para	Initial Pass/Fail: Pass	Overall Compliance: No
Severity Score: 0.25			
Codes/Mitigation Info/Possible Solution		Field Measurements/Component Compliance

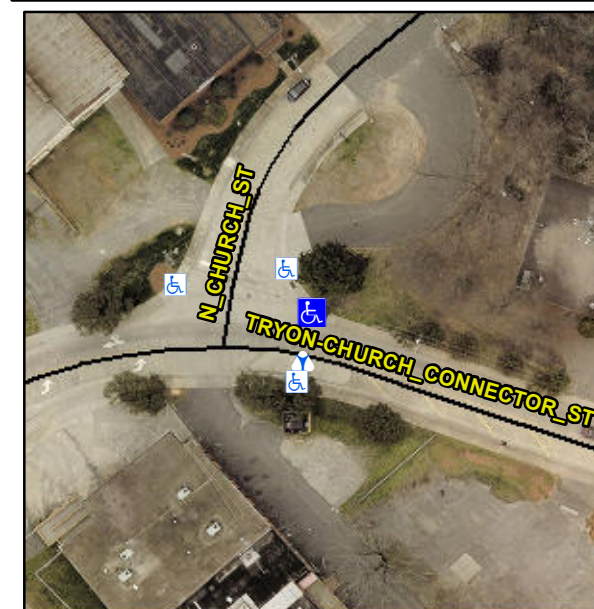
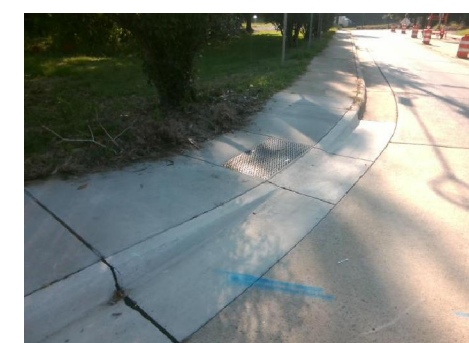
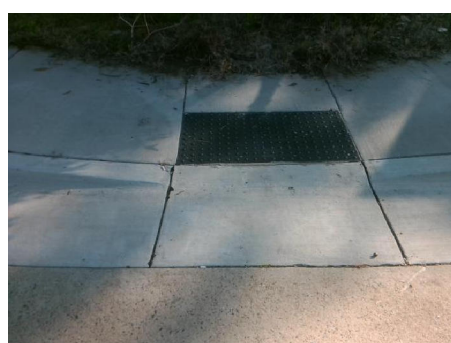
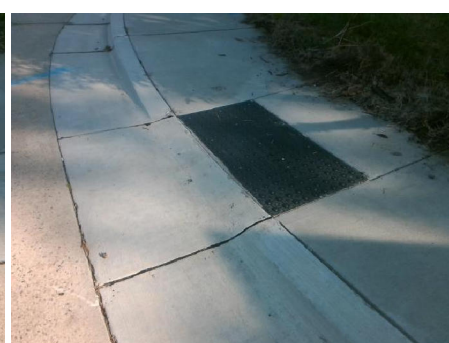
**RT RP < 5%**

**Not Found, R304.5.3, R304.2.1**

Compliance	Description	Data	Compliance	Description	Data
N/A	Ramp Length LT (in)	62.0	N/A	Ramp Length RT (in)	64.0
Yes	Ramp Width LT (in)	60.0	Yes	Ramp Width RT (in)	59.5
Yes	Ramp Slope LT (%)	7.7	Yes	Ramp Slope RT (%)	2.6
Yes	Ramp XSlope LT (%)	0.6	No	Ramp XSlope RT (%)	2.5
Yes	Landing Length (in)	60.0	Yes	DWS Provided?	Yes
No	Landing Width (in)	47.5	Yes	DWS Contrast?	Yes
Yes	Landing Slope (%)	0.8	Yes	DWS Length (in)	24.0
Yes	Landing X Slope (%)	2.0	Yes	DWS Full Width?	Yes
N/A	Landing Curb? (Y/N)	No	Yes	DWS Offset (in)	0.0
N/A	Shared Landing?	No			
Yes	Gutter Ponding?	No	Yes	Gutter Slope (%)	3.3
Yes	Gutter Lip Ht (in)	0.0	No	Gutter X Slope (%)	4.0
N/A	Painted X Walk1?	No	N/A	Painted X Walk2?	N/A
	X Walk 1 Direction	To S		X Walk 2 Direction	N/A
N/A	X Walk 1 Width (in)	N/A	N/A	X Walk 2 Width (in)	N/A
	X Walk 1 Slope (%)	2.6		X Walk 2 Slope (%)	N/A
	X Walk 1 X Slope (%)	1.1		X Walk 2 X Slope (%)	N/A
N/A	Ramp inside XWalk1?	N/A	N/A	Ramp inside XWalk2?	N/A

Road Slope (%)	N/A	N/A	Clear Space?	Yes
	Road X Slope (%)	N/A	N/A	Clear Space to XWalk (in)	N/A
Yes	Any Obstructions?	No	Yes	Storm Grate/Utility Hazard?	No
	Obstruction Type			Storm Grate/Utility Type	
		N/A			N/A
			Yes	Surface Condition? (G/P)	Good
			Replace	Curb Slope (%)	17.3

**Remove & Replace Entire Ramp.**  
**Remove & Replace Gutter.**
