Access Compliance Report

Public Rights-of-Way

(Curb Ramps)

Intersection ID: 17737	Main Street: SHARON_AMITY_RD	Cross Street: ADDISON_DR	Location: SE
ADA ID: 3B1787612444	Ramp Type: BlendTrans1	Initial Pass/Fail: Fail	Overall Compliance: No
Codes/Mitigation Info/Possible Solution			Severity Score: 10
			Field Measurements/Component Compliance

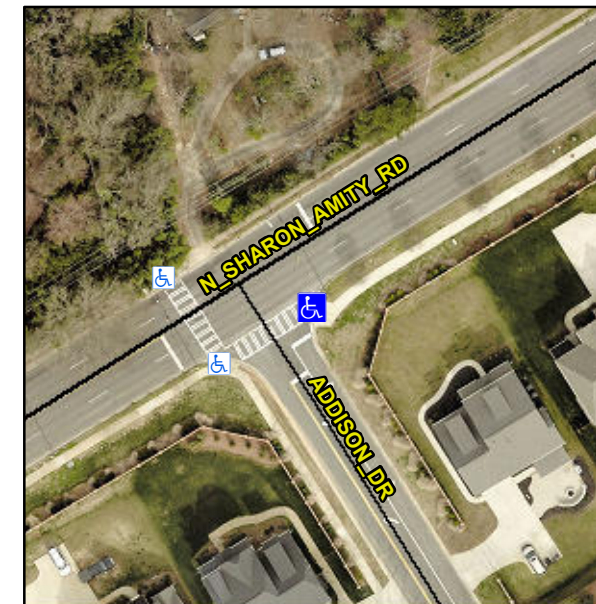
Not Found, R304.5.1, R304.5.3

Compliance	Description	Data	Compliance	Description	Data
N/A	Ramp Length (in)	60.0	Yes	BlendTrans Slope (%)	3.0
No	Ramp Width (in)	46.0	No	BlendTrans XSlope (%)	2.7
N/A	Flare Type LT	N/A	N/A	Flare Type RT	N/A
N/A	Flare Slope LT (%)	N/A	N/A	Flare Slope RT (%)	N/A
N/A	Flare Traversable LT?	N/A	N/A	Flare Traversable RT?	N/A
N/A	Landing Length (in)	N/A	N/A	DWS Provided?	N/A
N/A	Landing Width (in)	N/A	N/A	DWS Contrast?	N/A
N/A	Landing Slope (%)	N/A	N/A	DWS Length (in)	N/A
N/A	Landing X Slope (%)	N/A	N/A	DWS Full Width?	N/A
N/A	Landing Curb? (Y/N)	N/A	N/A	DWS Offset (in)	N/A
N/A	Shared Landing?	N/A			
N/A	Gutter Ponding?	N/A	N/A	Gutter Slope (%)	N/A
N/A	Gutter Lip Ht (in)	N/A	N/A	Gutter X Slope (%)	N/A
N/A	Painted X Walk1?	No	N/A	Painted X Walk2?	Yes
	X Walk 1 Direction	To NW		X Walk 2 Direction	To SW
	X Walk 1 Width (in)	N/A		X Walk 2 Width (in)	111.0
	X Walk 1 Slope (%)	1.5		X Walk 2 Slope (%)	0.4
	X Walk 1 X Slope (%)	0.9		X Walk 2 X Slope (%)	0.9

N/A	Ramp inside XWalk1?	N/A	N/A	Ramp inside XWalk2?	Yes
	Road Slope (%)	0.5		Clear Space?	N/A
	Road X Slope (%)	1.3	N/A	Clear Space to XWalk (in)	N/A
N/A	Any Obstructions?	N/A	N/A	Storm Grate/Utility Hazard?	N/A
	Obstruction Type			Storm Grate/Utility Type	
		N/A			N/A
			Yes	Surface Condition? (G/P)	Good
			No	Curb Slope (%)	13.4

Remove & Replace Curb Ramp With Two New Directional Ramps or Equivalent.
