Access Compliance Report

Public Rights-of-Way

(Curb Ramps)

Intersection ID: 27774	Main Street: BRYANT_FARMS_RD	Cross Street: HOUSTON_RIDGE_RD	Location: SE
ADA ID: 3B21E0E3FDDC	Ramp Type: PerpDiag	Initial Pass/Fail: Fail	Overall Compliance: No
Severity Score: 12.5			
Codes/Mitigation Info/Possible Solution		Field Measurements/Component Compliance

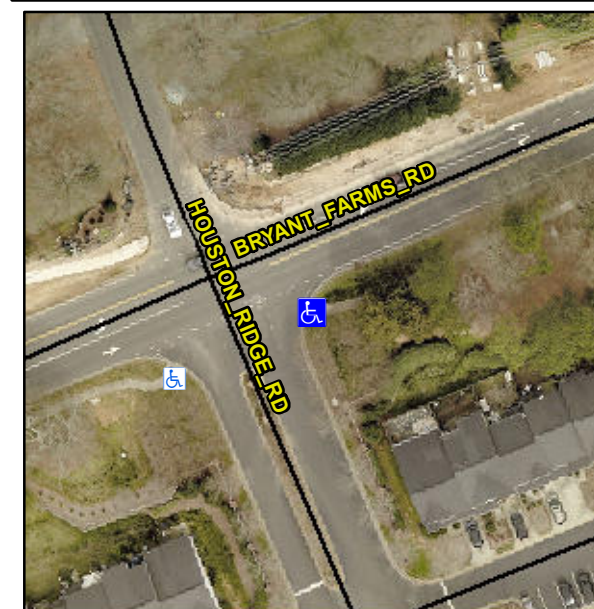
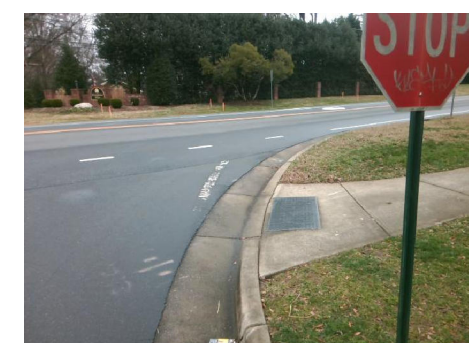
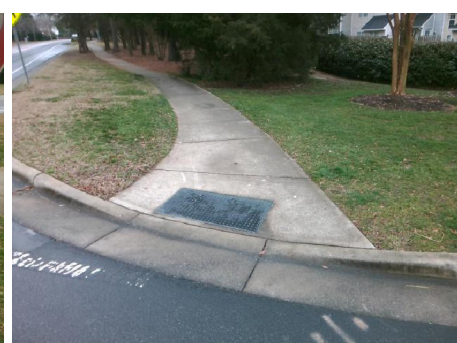
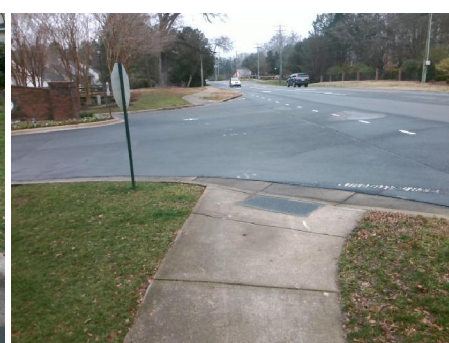
Not Found, R304.5.3

Compliance	Description	Data	Compliance	Description	Data
N/A	Ramp Length (in)	52.0	Yes	Ramp Slope (%)	5.2
Yes	Ramp Width (in)	48.0	No	Ramp XSlope (%)	5.1
N/A	Flare Type LT	N/A	N/A	Flare Type RT	N/A
N/A	Flare Slope LT (%)	N/A	N/A	Flare Slope RT (%)	N/A
N/A	Flare Traversable LT?	N/A	N/A	Flare Traversable RT?	N/A
N/A	Landing Length (in)	N/A	N/A	DWS Provided?	N/A
N/A	Landing Width (in)	N/A	N/A	DWS Contrast?	N/A
N/A	Landing Slope (%)	N/A	N/A	DWS Length (in)	N/A
N/A	Landing X Slope (%)	N/A	N/A	DWS Full Width?	N/A
N/A	Landing Curb? (Y/N)	N/A	N/A	DWS Offset (in)	N/A
N/A	Shared Landing?	N/A			
N/A	Gutter Ponding?	N/A	N/A	Gutter Slope (%)	N/A
N/A	Gutter Lip Ht (in)	N/A	N/A	Gutter X Slope (%)	N/A
N/A	Painted X Walk1?	No	N/A	Painted X Walk2?	No
	X Walk 1 Direction	To N		X Walk 2 Direction	To SW
N/A	X Walk 1 Width (in)	N/A	N/A	X Walk 2 Width (in)	N/A
	X Walk 1 Slope (%)	7.1		X Walk 2 Slope (%)	0.6
	X Walk 1 X Slope (%)	0.5		X Walk 2 X Slope (%)	7.6

N/A	Ramp inside XWalk1?	N/A	N/A	Ramp inside XWalk2?	N/A
	Road Slope (%)	4.9	N/A	Clear Space?	N/A
	Road X Slope (%)	5.9	N/A	Clear Space to XWalk (in)	N/A
N/A	Any Obstructions?	N/A	N/A	Storm Grate/Utility Hazard?	N/A
	Obstruction Type			Storm Grate/Utility Type	
		N/A			N/A
		Yes		Surface Condition? (G/P)	Good

Remove & Replace Curb Ramp With Two New Directional Ramps or Equivalent.

Total Cost: \$ 3200.00
