# Access Compliance Report

## Public Rights-of-Way

### (Curb Ramps)

Intersection ID: 10390	Main Street: ENDERLY_RD	Cross Street: TUCKASEEGEE_RD	Location: W
ADA ID: 3B26114B41DF	Ramp Type: Perp	Initial Pass/Fail: Fail	Overall Compliance: No
			Severity Score: 13.75

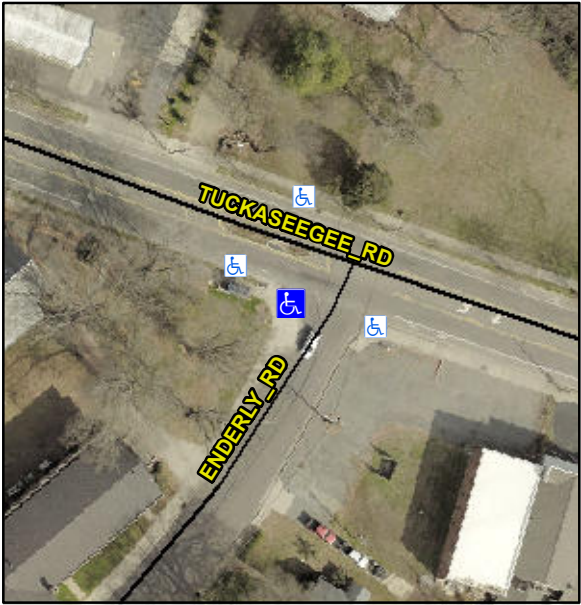
Possible Solutions:		<b>Compliance</b>	<b>Description</b>	<b>Data</b>
	Remove & Replace Entire Ramp.		N/A	Ramp Length (in)	73.0
			Yes	Ramp Width (in)	48.0
			N/A	Flare Type LT	N/A
			N/A	Flare Slope LT (%)	N/A
			N/A	Flare Traversable LT?	N/A
			N/A	Landing Length (in)	N/A
			N/A	Landing Width (in)	N/A
			N/A	Landing Slope (%)	N/A
			N/A	Landing X Slope (%)	N/A
<p>Surveyor Notes:</p> <p>N/A</p> <p>PROW/ADA:</p> <p>Not Found, R304.2.2, R304.5.3</p>			N/A	Flare Type RT	N/A
			N/A	Flare Slope RT (%)	N/A
			N/A	Flare Traversable RT?	N/A
			N/A	DWS Provided?	N/A
			N/A	DWS Contrast?	N/A
			N/A	DWS Length (in)	N/A
			N/A	DWS Full Width?	N/A
			N/A	DWS Offset (in)	N/A
			N/A	Shared Landing?	N/A
			N/A	Gutter Ponding?	N/A
			N/A	Gutter Lip Ht (in)	N/A
			N/A	Painted X Walk1?	No
				X Walk 1 Direction	To SE
			N/A	X Walk 1 Width (in)	N/A

X Walk 1 Slope (%)	6.8
				X Walk 1 X Slope (%)	5.6
			N/A	Ramp inside XWalk1?	N/A
				Road Slope (%)	N/A
				Road X Slope (%)	N/A
			N/A	Any Obstructions?	N/A
				Obstruction Type	
Total Cost:		\$ 1850.00			
			N/A		N/A
			Yes	Surface Condition? (G/P)	Good
