Access Compliance Report

Public Rights-of-Way

(Curb Ramps)

Intersection ID: 47899	Main Street: PIERSON_DR	Cross Street: E_INDEPENDENCE_BV/PIERSON_DR_RA	Location: W
ADA ID: 3B2F75C0606A	Ramp Type: Perp	Initial Pass/Fail: Fail	Overall Compliance: No
Severity Score: 21.25			
Codes/Mitigation Info/Possible Solution		Field Measurements/Component Compliance

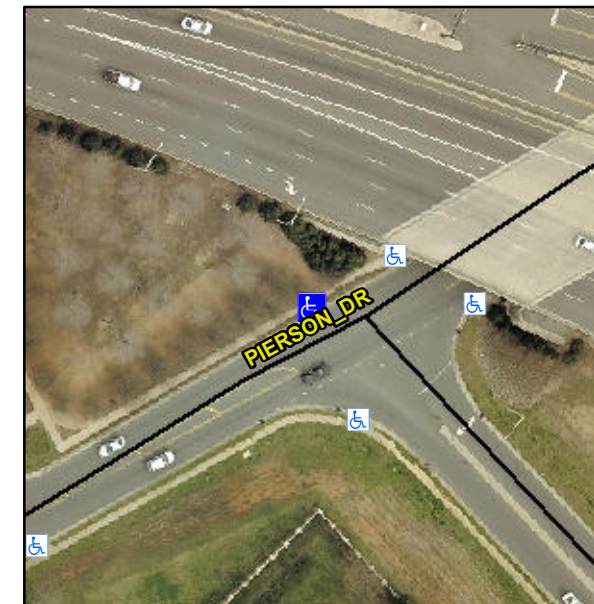
Not Found, R304.5.1, R304.2.2

Compliance	Description	Data	Compliance	Description	Data
N/A	Ramp Length (in)	84.0	No	Ramp Slope (%)	8.8
No	Ramp Width (in)	40.5	Yes	Ramp XSlope (%)	0.1
N/A	Flare Type LT	N/A	N/A	Flare Type RT	N/A
N/A	Flare Slope LT (%)	N/A	N/A	Flare Slope RT (%)	N/A
N/A	Flare Traversable LT?	N/A	N/A	Flare Traversable RT?	N/A
N/A	Landing Length (in)	N/A	N/A	DWS Provided?	N/A
N/A	Landing Width (in)	N/A	N/A	DWS Contrast?	N/A
N/A	Landing Slope (%)	N/A	N/A	DWS Length (in)	N/A
N/A	Landing X Slope (%)	N/A	N/A	DWS Full Width?	N/A
N/A	Landing Curb? (Y/N)	N/A	N/A	DWS Offset (in)	N/A
N/A	Shared Landing?	N/A			
N/A	Gutter Ponding?	N/A	N/A	Gutter Slope (%)	N/A
N/A	Gutter Lip Ht (in)	N/A	N/A	Gutter X Slope (%)	N/A
N/A	Painted X Walk1?	No	N/A	Painted X Walk2?	N/A
	X Walk 1 Direction	To S		X Walk 2 Direction	N/A
N/A	X Walk 1 Width (in)	N/A	N/A	X Walk 2 Width (in)	N/A
	X Walk 1 Slope (%)	0.0		X Walk 2 Slope (%)	N/A
	X Walk 1 X Slope (%)	0.8		X Walk 2 X Slope (%)	N/A

Possible Solutions:

Remove & Replace Entire Ramp.

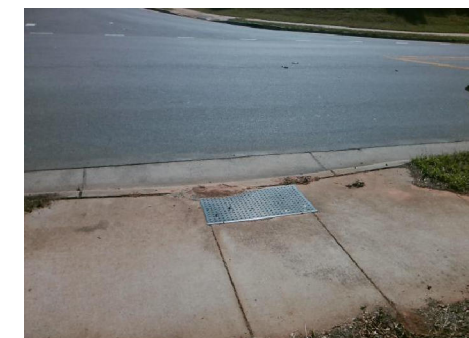
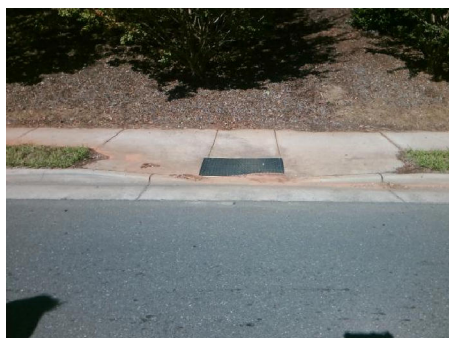
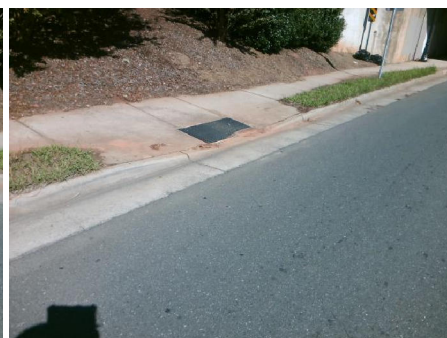
N/A	Ramp inside XWalk1?	N/A	N/A	Ramp inside XWalk2?	N/A
	Road Slope (%)	N/A	N/A	Clear Space?	N/A
	Road X Slope (%)	N/A	N/A	Clear Space to XWalk (in)	N/A
N/A	Any Obstructions?	N/A	N/A	Storm Grate/Utility Hazard?	N/A
	Obstruction Type			Storm Grate/Utility Type	
		N/A			N/A
			Yes	Surface Condition? (G/P)	Good
