# Access Compliance Report

## Public Rights-of-Way

| Intersection ID: 11775 | Main Street: E_18TH_ST | Cross Street: SEIGLE_AV | Location: SE |
| ADA ID: 3B34CF5469A7 | Ramp Type: BlendTrans1 | Initial Pass/Fail: Pass | Overall Compliance: No |

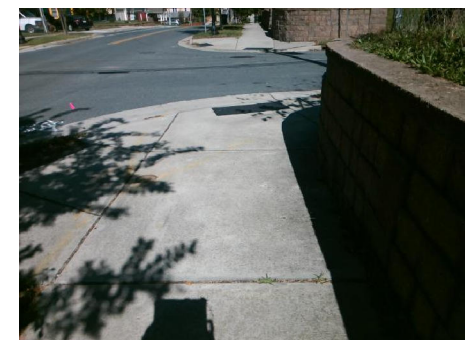
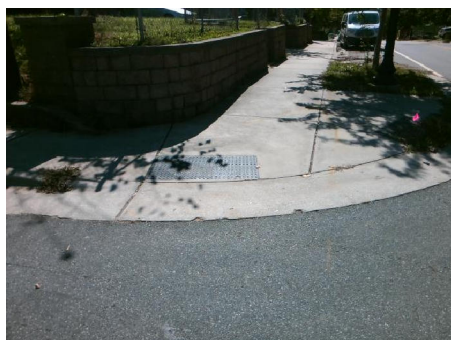
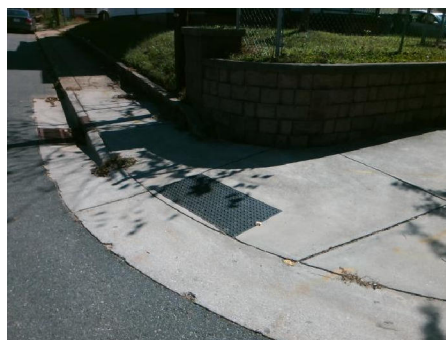
| Severity Score: 2.5 | | | |

**R304.2.2-Perp, R304.3.2-Para, R305.1.4, R305.2**

| Compliance | Description | Data | Compliance | Description | Data |
|---|---|---|---|---|---|
| No | Landing Slope (%) | 4.3 | Yes | DWS Length (in) | 24.5 |
| Yes | Landing X Slope (%) | 1.3 | No | DWS Full Width? | No |
| N/A | Landing Curb? (Y/N) | No | No | DWS Offset (in) | 3.0 |

**Remove & Replace Curb Ramp With Two New Directional Ramps or Equivalent.**
