Access Compliance Report

Public Rights-of-Way

(Curb Ramps)

Intersection ID: 22827	Main Street: DEER_HOLLOW_CT	Cross Street: FOX_COVE_DR	Location: SW
ADA ID: 3B3E8827B447	Ramp Type: PerpDiag	Initial Pass/Fail: Fail	Overall Compliance: No
Severity Score: 8.75			
Codes/Mitigation Info/Possible Solution		Field Measurements/Component Compliance

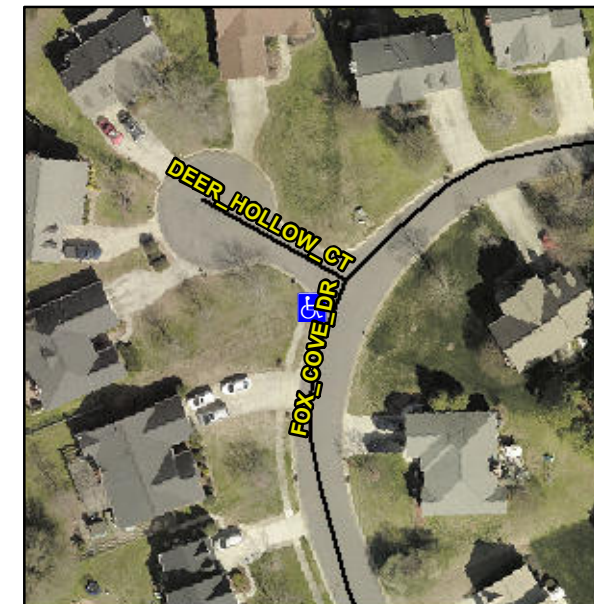
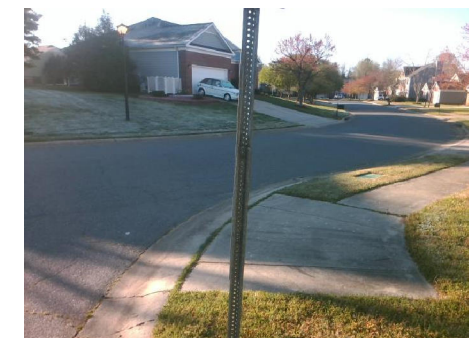
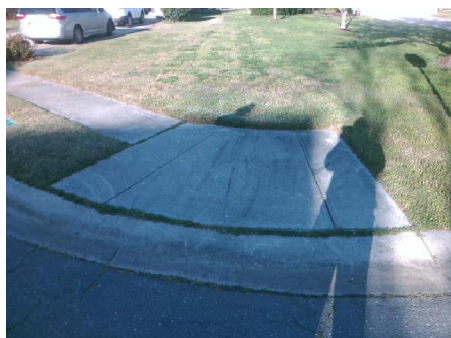
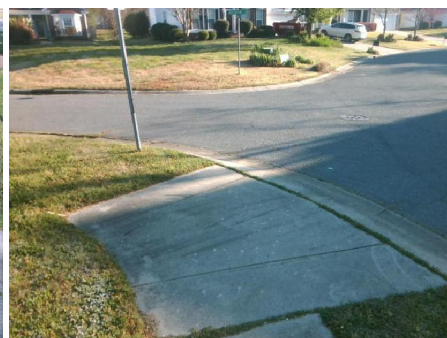
Compliance	Description	Data	Compliance	Description	Data
N/A	Ramp Length (in)	94.0	Yes	Ramp Slope (%)	6.0
No	Ramp Width (in)	43.0	Yes	Ramp XSlope (%)	0.0
N/A	Flare Type LT	N/A	N/A	Flare Type RT	N/A
N/A	Flare Slope LT (%)	N/A	N/A	Flare Slope RT (%)	N/A
N/A	Flare Traversable LT?	N/A	N/A	Flare Traversable RT?	N/A
N/A	Landing Length (in)	N/A	N/A	DWS Provided?	N/A
N/A	Landing Width (in)	N/A	N/A	DWS Contrast?	N/A
N/A	Landing Slope (%)	N/A	N/A	DWS Length (in)	N/A
N/A	Landing X Slope (%)	N/A	N/A	DWS Full Width?	N/A
N/A	Landing Curb? (Y/N)	N/A	N/A	DWS Offset (in)	N/A
N/A	Shared Landing?	N/A			
N/A	Gutter Ponding?	N/A	N/A	Gutter Slope (%)	N/A
N/A	Gutter Lip Ht (in)	N/A	N/A	Gutter X Slope (%)	N/A
N/A	Painted X Walk1?	No	N/A	Painted X Walk2?	No
	X Walk 1 Direction	To SE		X Walk 2 Direction	To NE
N/A	X Walk 1 Width (in)	N/A	N/A	X Walk 2 Width (in)	N/A
	X Walk 1 Slope (%)	4.2		X Walk 2 Slope (%)	4.3
	X Walk 1 X Slope (%)	2.8		X Walk 2 X Slope (%)	0.6

N/A	Ramp inside XWalk1?	N/A	N/A	Ramp inside XWalk2?	N/A
	Road Slope (%)	2.0	N/A	Clear Space?	N/A
	Road X Slope (%)	2.6	N/A	Clear Space to XWalk (in)	N/A
N/A	Any Obstructions?	N/A	N/A	Storm Grate/Utility Hazard?	N/A
	Obstruction Type			Storm Grate/Utility Type	
		N/A			N/A
			Yes	Surface Condition? (G/P)	Good

Possible Solutions:

Remove & Replace Curb Ramp With Two New Directional Ramps or Equivalent.

R304.5.1
