Access Compliance Report

Public Rights-of-Way

(Curb Ramps)

Intersection ID: 13891	Main Street: CLEMENT_AV	Cross Street: E_7TH_ST	Location: NW
ADA ID: 3B42ADAB374F	Ramp Type: Directional1	Initial Pass/Fail: Fail	Overall Compliance: No
Severity Score: 12.5			
Codes/Mitigation Info/Possible Solution		Field Measurements/Component Compliance

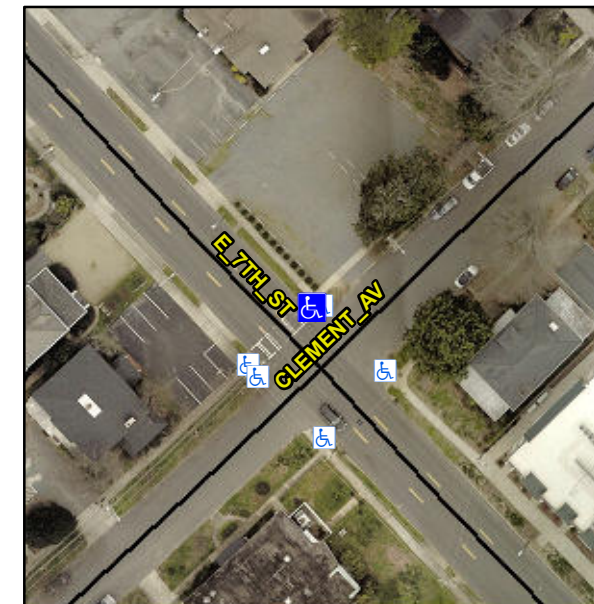
Compliance	Description	Data	Compliance	Description	Data
N/A	Ramp Length (in)	46.0	N/A	Grade Break?	N/A
Yes	Ramp Width (in)	48.0	N/A	Grade Break Slope (%)	0.0
No	Ramp Slope (%)	8.7	N/A	Grade Break XSlope (%)	0.0
Yes	Ramp XSlope (%)	2.0			
N/A	Flare Type LT	N/A	N/A	Flare Type RT	N/A
N/A	Flare Slope LT (%)	N/A	N/A	Flare Slope RT (%)	0.0
N/A	Flare Traversable LT?	N/A	N/A	Flare Traversable RT?	N/A
N/A	Landing Length (in)	0.0	N/A	DWS Provided?	N/A
N/A	Landing Width (in)	0.0	N/A	DWS Contrast?	N/A
N/A	Landing Slope (%)	0.0	N/A	DWS Length (in)	N/A
N/A	Landing X Slope (%)	0.0	N/A	DWS Full Width?	N/A
N/A	Landing Curb? (Y/N)	N/A	N/A	DWS Offset LT (in)	N/A
N/A	Shared Landing?	N/A	N/A	DWS Offset RT (in)	N/A
N/A	Gutter Ponding?	0.0	N/A	Gutter Slope (%)	N/A
N/A	Gutter Lip Ht (in)	0.0	N/A	Gutter X Slope (%)	N/A
N/A	Painted X Walk1?	Yes		Road Slope (%)	2.5
	X Walk 1 Direction	To SW		Road X Slope (%)	2.1
	X Walk 1 Width (in)	110.0		Clear Space?	N/A

X Walk 1 Slope (%)	2.5	N/A	Clear Space to XWalk (in)	N/A
	X Walk 1 X Slope (%)	2.1	N/A	Storm Grate/Utility Hazard?	N/A
N/A	Ramp inside XWalk1?	Yes		Storm Grate/Utility Type	
N/A	Any Obstructions?	N/A			N/A
	Obstruction Type		Yes	Surface Condition? (G/P)	Good
			N/A	Curb Slope (%)	4.9

Possible Solutions:

Remove & Replace Entire Ramp.

PROW/ADA:

R304.2.2
