# Access Compliance Report

## Public Rights-of-Way

### (Curb Ramps)

Intersection ID: 11625	Main Street: E_11TH_ST	Cross Street: N_COLLEGE_ST	Location: W
ADA ID: 3B4919098420	Ramp Type: PerpDiag	Initial Pass/Fail: Fail	Overall Compliance: No
Severity Score: 12.5			
Codes/Mitigation Info/Possible Solution		Field Measurements/Component Compliance

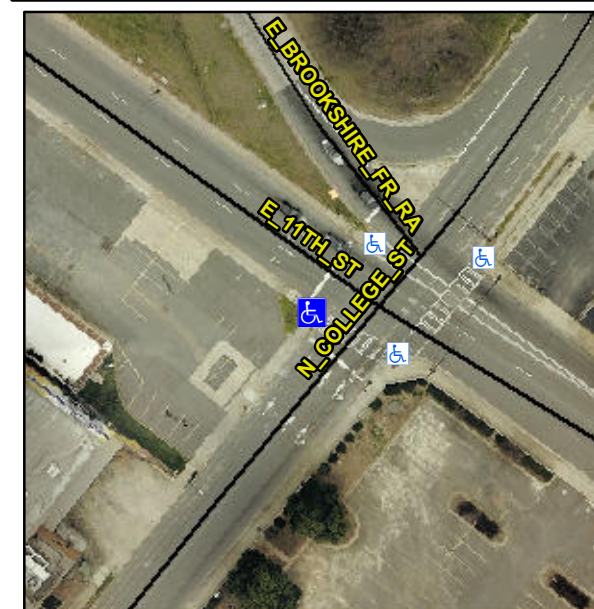
**Not Found, R304.2.2**

Compliance	Description	Data	Compliance	Description	Data
N/A	Ramp Length (in)	42.0	No	Ramp Slope (%)	10.8
Yes	Ramp Width (in)	48.0	Yes	Ramp XSlope (%)	0.2
N/A	Flare Type LT	N/A	N/A	Flare Type RT	N/A
N/A	Flare Slope LT (%)	N/A	N/A	Flare Slope RT (%)	N/A
N/A	Flare Traversable LT?	N/A	N/A	Flare Traversable RT?	N/A
N/A	Landing Length (in)	N/A	N/A	DWS Provided?	N/A
N/A	Landing Width (in)	N/A	N/A	DWS Contrast?	N/A
N/A	Landing Slope (%)	N/A	N/A	DWS Length (in)	N/A
N/A	Landing X Slope (%)	N/A	N/A	DWS Full Width?	N/A
N/A	Landing Curb? (Y/N)	N/A	N/A	DWS Offset (in)	N/A
N/A	Shared Landing?	N/A			
N/A	Gutter Ponding?	Yes	N/A	Gutter Slope (%)	N/A
N/A	Gutter Lip Ht (in)	N/A	N/A	Gutter X Slope (%)	N/A
N/A	Painted X Walk1?	Yes	N/A	Painted X Walk2?	No
	X Walk 1 Direction	To SE		X Walk 2 Direction	To NE
N/A	X Walk 1 Width (in)	118.0	N/A	X Walk 2 Width (in)	N/A
	X Walk 1 Slope (%)	1.1		X Walk 2 Slope (%)	3.3
	X Walk 1 X Slope (%)	3.9		X Walk 2 X Slope (%)	1.6

N/A	Ramp inside XWalk1?	Yes	N/A	Ramp inside XWalk2?	N/A
	Road Slope (%)	1.4	N/A	Clear Space?	N/A
	Road X Slope (%)	4.7	N/A	Clear Space to XWalk (in)	N/A
N/A	Any Obstructions?	N/A	N/A	Storm Grate/Utility Hazard?	N/A
	Obstruction Type			Storm Grate/Utility Type	
		N/A			N/A
		Yes		Surface Condition? (G/P)	Good

Possible Solutions:

**Remove & Replace Curb Ramp With Two New Directional Ramps or Equivalent.**

Total Cost: \$ 3200.00
