# Access Compliance Report

## Public Rights-of-Way

### (Curb Ramps)

Intersection ID: 49133	Main Street: EWERT_CUT_LN	Cross Street: AMBER_LEIGH_WAY_DR	Location: NE
ADA ID: 3B541839C7B6	Ramp Type: Perp	Initial Pass/Fail: Fail	Overall Compliance: No
Severity Score: 10			
Codes/Mitigation Info/Possible Solution		Field Measurements/Component Compliance

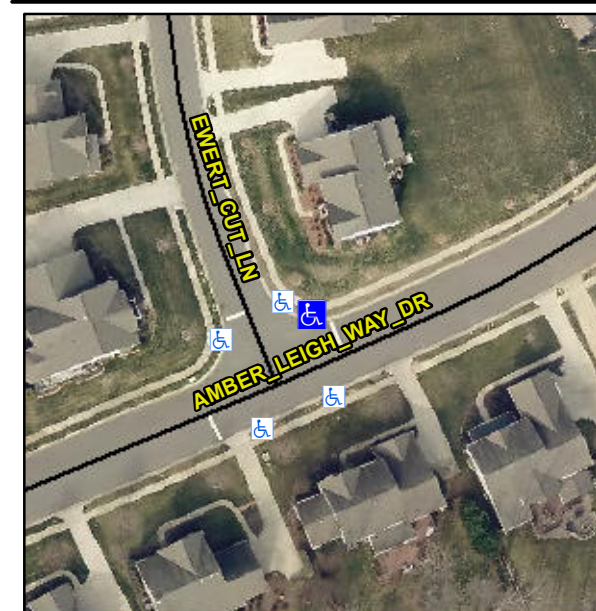
**Not Found, R304.5.1, R304.5.3**

Compliance	Description	Data	Compliance	Description	Data
N/A	Ramp Length (in)	48.0	Yes	Ramp Slope (%)	7.4
No	Ramp Width (in)	46.5	No	Ramp XSlope (%)	4.2
N/A	Flare Type LT	N/A	N/A	Flare Type RT	N/A
N/A	Flare Slope LT (%)	N/A	N/A	Flare Slope RT (%)	N/A
N/A	Flare Traversable LT?	N/A	N/A	Flare Traversable RT?	N/A
N/A	Landing Length (in)	N/A	N/A	DWS Provided?	N/A
N/A	Landing Width (in)	N/A	N/A	DWS Contrast?	N/A
N/A	Landing Slope (%)	N/A	N/A	DWS Length (in)	N/A
N/A	Landing X Slope (%)	N/A	N/A	DWS Full Width?	N/A
N/A	Landing Curb? (Y/N)	N/A	N/A	DWS Offset (in)	N/A
N/A	Shared Landing?	N/A			
N/A	Gutter Ponding?	N/A	N/A	Gutter Slope (%)	N/A
N/A	Gutter Lip Ht (in)	N/A	N/A	Gutter X Slope (%)	N/A
N/A	Painted X Walk1?	No	N/A	Painted X Walk2?	N/A
	X Walk 1 Direction	To S		X Walk 2 Direction	N/A
N/A	X Walk 1 Width (in)	N/A	N/A	X Walk 2 Width (in)	N/A
	X Walk 1 Slope (%)	2.6		X Walk 2 Slope (%)	N/A
	X Walk 1 X Slope (%)	1.5		X Walk 2 X Slope (%)	N/A

N/A	Ramp inside XWalk1?	N/A	N/A	Ramp inside XWalk2?	N/A
	Road Slope (%)	N/A	N/A	Clear Space?	N/A
	Road X Slope (%)	N/A	N/A	Clear Space to XWalk (in)	N/A
N/A	Any Obstructions?	N/A	N/A	Storm Grate/Utility Hazard?	N/A
	Obstruction Type			Storm Grate/Utility Type	
		N/A			N/A
			Yes	Surface Condition? (G/P)	Good

**Remove & Replace Entire Ramp.**

Total Cost: \$ 1850.00
