Access Compliance Report

Public Rights-of-Way

(Curb Ramps)

Intersection ID: N/A	Main Street: TAMARACK DR	Cross Street: SINGLELEAF LN	Location: N
ADA ID: 3B5FD8FCDA59	Ramp Type: Perp	Initial Pass/Fail: Fail	Overall Compliance: No
Severity Score: 1.25			
Codes/Mitigation Info/Possible Solution		Field Measurements/Component Compliance

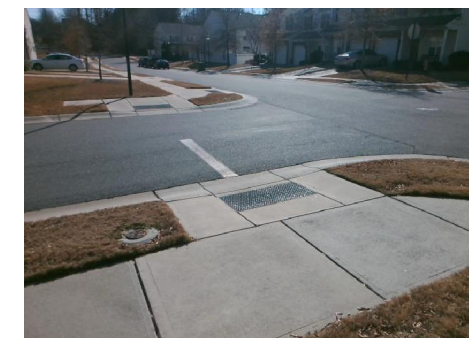
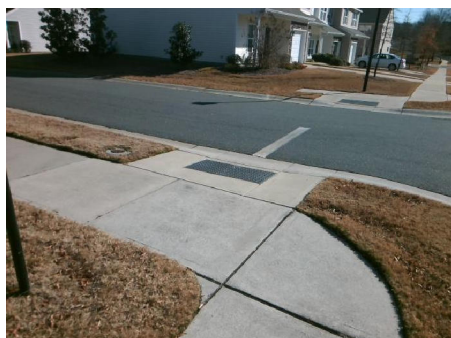
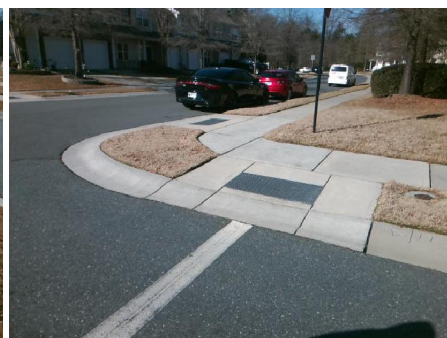
Not Found, R304.5.3

Compliance	Description	Data	Compliance	Description	Data
N/A	Ramp Length (in)	49.0	Yes	Ramp Slope (%)	7.7
Yes	Ramp Width (in)	48.0	No	Ramp XSlope (%)	2.9
N/A	Flare Type LT	N/A	N/A	Flare Type RT	N/A
N/A	Flare Slope LT (%)	N/A	N/A	Flare Slope RT (%)	N/A
N/A	Flare Traversable LT?	No	N/A	Flare Traversable RT?	No
N/A	Landing Length (in)	N/A	N/A	DWS Provided?	N/A
N/A	Landing Width (in)	N/A	N/A	DWS Contrast?	N/A
N/A	Landing Slope (%)	N/A	N/A	DWS Length (in)	N/A
N/A	Landing X Slope (%)	N/A	N/A	DWS Full Width?	N/A
N/A	Landing Curb? (Y/N)	N/A	N/A	DWS Offset (in)	N/A
N/A	Shared Landing?	N/A			
N/A	Gutter Ponding?	N/A	N/A	Gutter Slope (%)	N/A
N/A	Gutter Lip Ht (in)	N/A	N/A	Gutter X Slope (%)	N/A
N/A	Painted X Walk1?	No	N/A	Painted X Walk2?	N/A
	X Walk 1 Direction	To SE		X Walk 2 Direction	N/A
N/A	X Walk 1 Width (in)	N/A	N/A	X Walk 2 Width (in)	N/A
	X Walk 1 Slope (%)	1.9		X Walk 2 Slope (%)	N/A
	X Walk 1 X Slope (%)	1.8		X Walk 2 X Slope (%)	N/A

N/A	Ramp inside XWalk1?	No	N/A	Ramp inside XWalk2?	N/A
	Road Slope (%)	N/A	N/A	Clear Space?	N/A
	Road X Slope (%)	N/A	N/A	Clear Space to XWalk (in)	N/A
N/A	Any Obstructions?	N/A	N/A	Storm Grate/Utility Hazard?	N/A
	Obstruction Type			Storm Grate/Utility Type	
		N/A			N/A
		Yes		Surface Condition? (G/P)	Good

Remove & Replace Entire Ramp.
