# Access Compliance Report

## Public Rights-of-Way

| Intersection ID: 17334 | Main Street: LYNNWOOD_DR | Cross Street: STERLING_RD | Location: NW |
| ADA ID: 3B6F3B486529 | Ramp Type: PerpDiag | Initial Pass/Fail: Pass | Overall Compliance: No |

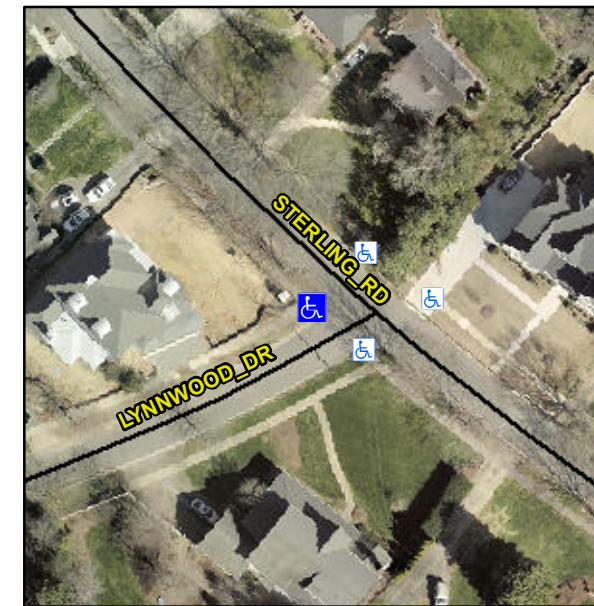
**Not Found, R304.5.3, R304.2.2-Perp, R304.3.2-Para, R305.2**

| Compliance | Description | Data | Compliance | Description | Data |
|---|---|---|---|---|---|
| Yes | Ramp Width (in) | 48.0 | No | Ramp XSlope (%) | 3.0 |
| No | Landing Slope (%) | 3.3 | Yes | DWS Length (in) | 24.5 |
| No | Landing X Slope (%) | 2.4 | Yes | DWS Full Width? | Yes |
| N/A | Landing Curb? (Y/N) | No | No | DWS Offset (in) | 4.0 |
| Yes | Gutter Lip Ht (in) | 0.0 | No | Gutter X Slope (%) | 2.4 |

**Remove & Replace Curb Ramp With Two New Directional Ramps or Equivalent. Remove & Replace Gutter.**
