# Access Compliance Report Public Rights-of-Way (Curb Ramps)

Intersection ID: 10020420      Main Street: BALLANTYNE\_VILLAGE\_WY      Cross Street: N/A      Location: N

ADA ID: 3B7328B651BD      Ramp Type: Perp      Initial Pass/Fail: Fail      Overall Compliance: No      Severity Score: 46.25

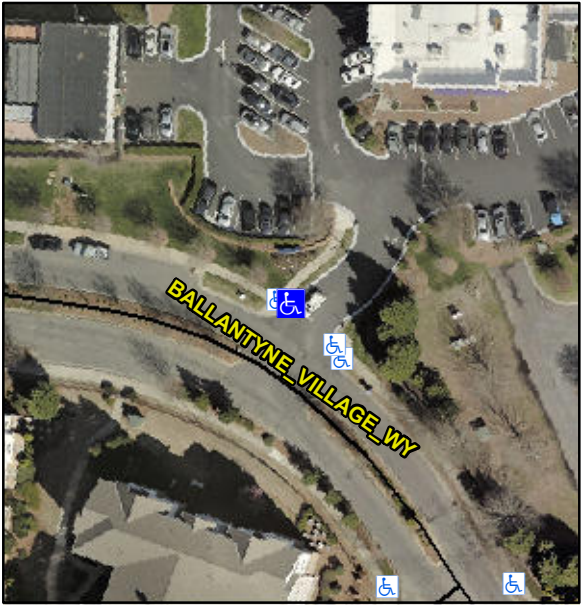
PROW/ADA:  
**Not Found, R304.5.1, R304.2.2, R304.5.3**

Compliance	Description	Data	Compliance	Description	Data
N/A	Ramp Length (in)	108.0	No	Ramp Slope (%)	8.8
No	Ramp Width (in)	45.0	No	Ramp XSlope (%)	7.9
N/A	Flare Type LT	N/A	N/A	Flare Type RT	N/A
N/A	Flare Slope LT (%)	N/A	N/A	Flare Slope RT (%)	N/A
N/A	Flare Traversable LT?	N/A	N/A	Flare Traversable RT?	N/A
N/A	Landing Length (in)	N/A	N/A	DWS Provided?	N/A
N/A	Landing Width (in)	N/A	N/A	DWS Contrast?	N/A
N/A	Landing Slope (%)	N/A	N/A	DWS Length (in)	N/A
N/A	Landing X Slope (%)	N/A	N/A	DWS Full Width?	N/A
N/A	Landing Curb? (Y/N)	N/A	N/A	DWS Offset (in)	N/A
N/A	Shared Landing?	N/A			
N/A	Gutter Ponding?	N/A	N/A	Gutter Slope (%)	N/A
N/A	Gutter Lip Ht (in)	N/A	N/A	Gutter X Slope (%)	N/A
N/A	Painted X Walk1?	No	N/A	Painted X Walk2?	N/A
	X Walk 1 Direction	To SE		X Walk 2 Direction	N/A
N/A	X Walk 1 Width (in)	N/A	N/A	X Walk 2 Width (in)	N/A
	X Walk 1 Slope (%)	1.8		X Walk 2 Slope (%)	N/A
	X Walk 1 X Slope (%)	7.0		X Walk 2 X Slope (%)	N/A

N/A	Ramp inside XWalk1?	N/A	N/A	Ramp inside XWalk2?	N/A
	Road Slope (%)	N/A	N/A	Clear Space?	N/A
	Road X Slope (%)	N/A	N/A	Clear Space to XWalk (in)	N/A
N/A	Any Obstructions?	N/A	N/A	Storm Grate/Utility Hazard?	N/A
	Obstruction Type			Storm Grate/Utility Type	
			N/A		N/A
			Yes	Surface Condition? (G/P)	Good

Possible Solutions:  
**Remove & Replace Entire Ramp.**

Total Cost:      \$      1850.00
