Access Compliance Report

Public Rights-of-Way

(Curb Ramps)

Intersection ID: 13056	Main Street: S_MINT_ST	Cross Street: W_BLAND_ST	Location: E
ADA ID: 3B82B48502DD	Ramp Type: PerpDiag	Initial Pass/Fail: Fail	Overall Compliance: No
		Severity Score: 8.75

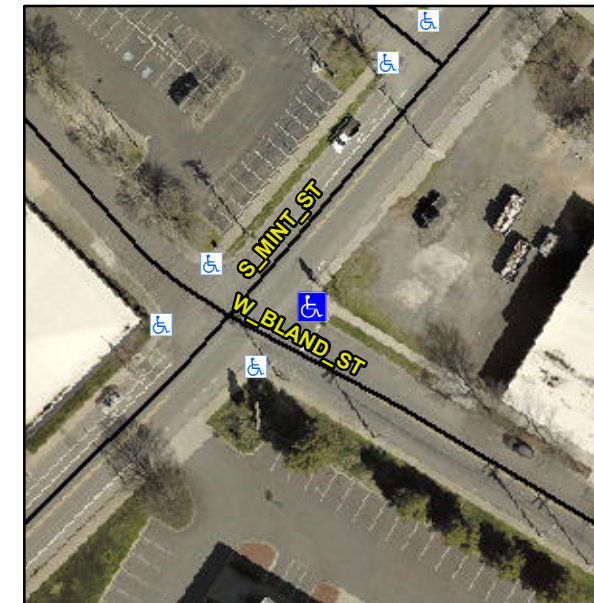
Compliance	Description	Data	Compliance	Description	Data
N/A	Ramp Length (in)	59.0	Yes	Ramp Slope (%)	6.7
No	Ramp Width (in)	43.0	Yes	Ramp XSlope (%)	0.0
N/A	Flare Type LT	N/A	N/A	Flare Type RT	N/A
N/A	Flare Slope LT (%)	N/A	N/A	Flare Slope RT (%)	N/A
N/A	Flare Traversable LT?	N/A	N/A	Flare Traversable RT?	N/A
N/A	Landing Length (in)	N/A	N/A	DWS Provided?	N/A
N/A	Landing Width (in)	N/A	N/A	DWS Contrast?	N/A
N/A	Landing Slope (%)	N/A	N/A	DWS Length (in)	N/A
N/A	Landing X Slope (%)	N/A	N/A	DWS Full Width?	N/A
N/A	Landing Curb? (Y/N)	N/A	N/A	DWS Offset (in)	N/A
N/A	Shared Landing?	N/A			
N/A	Gutter Ponding?	N/A	N/A	Gutter Slope (%)	N/A
N/A	Gutter Lip Ht (in)	N/A	N/A	Gutter X Slope (%)	N/A
N/A	Painted X Walk1?	No	N/A	Painted X Walk2?	No
	X Walk 1 Direction	To NW		X Walk 2 Direction	To SW
N/A	X Walk 1 Width (in)	N/A	N/A	X Walk 2 Width (in)	N/A
	X Walk 1 Slope (%)	4.7		X Walk 2 Slope (%)	5.8
	X Walk 1 X Slope (%)	4.3		X Walk 2 X Slope (%)	1.2

N/A	Ramp inside XWalk1?	N/A	N/A	Ramp inside XWalk2?	N/A
	Road Slope (%)	0.9	N/A	Clear Space?	N/A
	Road X Slope (%)	5.9	N/A	Clear Space to XWalk (in)	N/A
N/A	Any Obstructions?	N/A	N/A	Storm Grate/Utility Hazard?	N/A
	Obstruction Type			Storm Grate/Utility Type	
		N/A			N/A
		Yes		Surface Condition? (G/P)	Good

Remove & Replace Curb Ramp With Two New Directional Ramps or Equivalent.
