## Access Compliance Report Public Rights-of-Way (Curb Ramps)

Intersection ID: 47908Main Street:UNIVERSITY\_CITY\_BVCross Street:UNIVERSITY\_CITY\_BVLocation:NWADA ID: 3B9681338C50Ramp Type:PerpInitial Pass/Fail:FailOverall Compliance:NoSeverity Score:21.25

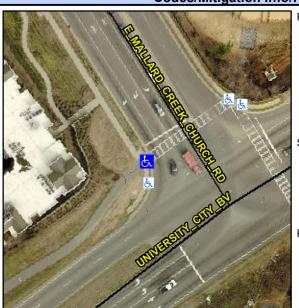
Compl	iance Description	Data		liance Description	Data
N/A	Ramp Length (in)	70.5	No	Ramp Slope (%)	8.6
No	Ramp Width (in)	40.0	Yes	Ramp XSlope (%)	1.2
N/A	Flare Type LT	N/A	N/A	Flare Type RT	N/A
N/A	Flare Slope LT (%)	N/A	N/A	Flare Slope RT (%)	N/A
N/A	Flare Traversable LT?	N/A	N/A	Flare Traversable RT?	N/A
N/A	Landing Length (in)	N/A	N/A	DWS Provided?	N/A
N/A	Landing Width (in)	N/A	N/A	DWS Contrast?	N/A
N/A	Landing Slope (%)	N/A	N/A	DWS Length (in)	N/A
N/A	Landing X Slope (%)	N/A	N/A	DWS Full Width?	N/A
N/A	Landing Curb? (Y/N)	N/A	N/A	DWS Offset (in)	N/A
N/A	Shared Landing?	N/A			
N/A	Gutter Ponding?	N/A	N/A	Gutter Slope (%)	N/A
N/A	Gutter Lip Ht (in)	N/A	N/A	Gutter X Slope (%)	N/A
N/A	Painted X Walk1?	Yes	N/A	Painted X Walk2?	N/A
	X Walk 1 Direction	To NE		X Walk 2 Direction	N/A
N/A	X Walk 1 Width (in)	113.0	N/A	X Walk 2 Width (in)	N/A
	X Walk 1 Slope (%)	1.5		X Walk 2 Slope (%)	N/A
	X Walk 1 X Slope (%)	0.0		X Walk 2 X Slope (%)	N/A

N/A	Ramp inside XWalk1?	Yes	N/A	Ramp inside XWalk2?	N/A
	Road Slope (%)	N/A	N/A	Clear Space?	N/A
	Road X Slope (%)	N/A	N/A	Clear Space to XWalk (in)	N/A
N/A	Any Obstructions?	N/A	N/A	Storm Grate/Utility Hazard?	N/A
	Obstruction Type		l	Storm Grate/Utility Type	
		N/A			N/A
			Yes	Surface Condition? (G/P)	Good

Possible Solution	
Possible Solutions:	<u>c</u>
Remove & Replace Entire Ramp.	
	N
	N
	N
	N
	N
Surveyor Notes:	N
N/A	N
	N
	N
	N
PROW/ADA:	N
Not Found, R304.5.1, R304.2.2	N/
	N
	N
