Access Compliance Report

Public Rights-of-Way

(Curb Ramps)

Intersection ID: 46360	Main Street: GARDNER_LN	Cross Street: GARDNER_POND_CT	Location: NE
ADA ID: 3B9752FE7175	Ramp Type: Perp	Initial Pass/Fail: Fail	Overall Compliance: No
			Severity Score: 26.25

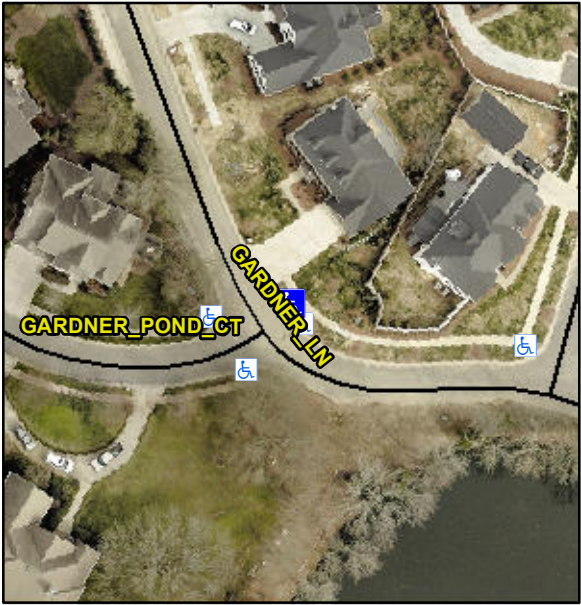
<p>Street 1 Name GARDNER POND LN</p> <p>Stop Condition-Street 2 None</p> <p>Street 2 Name N/A</p> <p>Stop Condition-Street 1 N/A</p>	<p>Possible Solutions:</p> <p>Remove & Replace Entire Ramp.</p> <p>Surveyor Notes:</p> <p>N/A</p> <p>PROW/ADA:</p> <p>R304.2.2</p>	<p>Compliance</p> <p>Description</p> <p>Data</p>	<p>Compliance</p> <p>Description</p> <p>Data</p>				
		N/A	Ramp Length (in)	96.0	No	Ramp Slope (%)	12.1
		Yes	Ramp Width (in)	48.0	Yes	Ramp XSlope (%)	3.5
		N/A	Flare Type LT	N/A	N/A	Flare Type RT	N/A
		N/A	Flare Slope LT (%)	N/A	N/A	Flare Slope RT (%)	N/A
		N/A	Flare Traversable LT?	N/A	N/A	Flare Traversable RT?	N/A
		N/A	Landing Length (in)	N/A	N/A	DWS Provided?	N/A
		N/A	Landing Width (in)	N/A	N/A	DWS Contrast?	N/A
		N/A	Landing Slope (%)	N/A	N/A	DWS Length (in)	N/A
		N/A	Landing X Slope (%)	N/A	N/A	DWS Full Width?	N/A

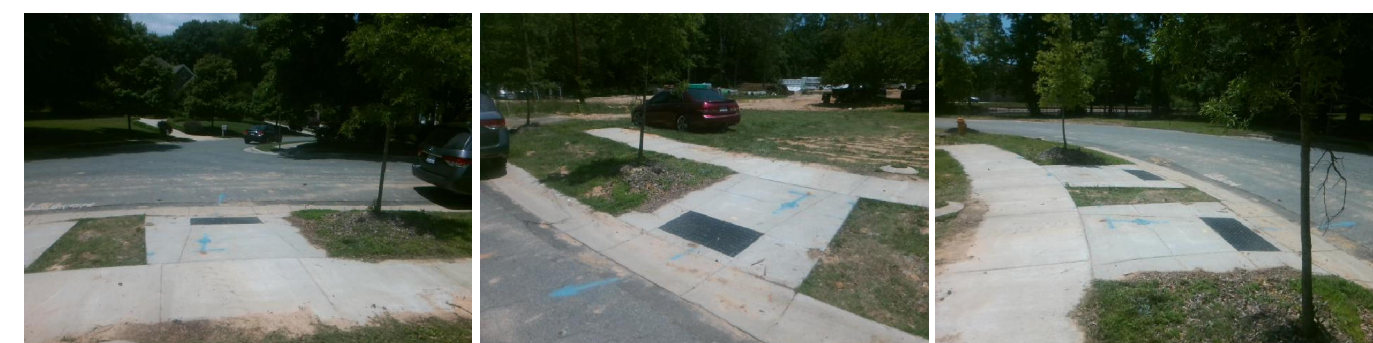
N/A	Landing Curb? (Y/N)	N/A	N/A	DWS Offset (in)	N/A
		N/A	Shared Landing?	N/A			
		N/A	Gutter Ponding?	N/A	N/A	Gutter Slope (%)	N/A
		N/A	Gutter Lip Ht (in)	N/A	N/A	Gutter X Slope (%)	N/A
		N/A	Painted X Walk1?	No	N/A	Painted X Walk2?	N/A
			X Walk 1 Direction	To W		X Walk 2 Direction	N/A
		N/A	X Walk 1 Width (in)	N/A	N/A	X Walk 2 Width (in)	N/A
			X Walk 1 Slope (%)	3.6		X Walk 2 Slope (%)	N/A
			X Walk 1 X Slope (%)	4.6		X Walk 2 X Slope (%)	N/A
		N/A	Ramp inside XWalk1?	N/A	N/A	Ramp inside XWalk2?	N/A
			Road Slope (%)	N/A	N/A	Clear Space?	N/A
			Road X Slope (%)	N/A	N/A	Clear Space to XWalk (in)	N/A
		N/A	Any Obstructions?	N/A	N/A	Storm Grate/Utility Hazard?	N/A
			Obstruction Type			Storm Grate/Utility Type	
					N/A		N/A
					Yes	Surface Condition? (G/P)	Good
Total Cost:		\$	1850.00
