Access Compliance Report

Public Rights-of-Way

(Curb Ramps)

Intersection ID: 23730	Main Street: PROVIDENCE_RD	Cross Street: CEDAR_CROFT_DR	Location: SW
ADA ID: 3B987E0C2AC1	Ramp Type: Perp	Initial Pass/Fail: Fail	Overall Compliance: No
Severity Score: 48.75			
Codes/Mitigation Info/Possible Solution		Field Measurements/Component Compliance

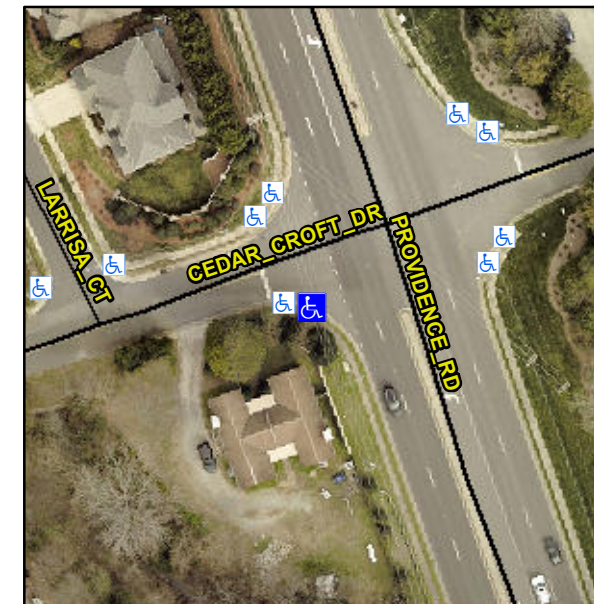
Compliance	Description	Data	Compliance	Description	Data
N/A	Ramp Length (in)	71.0	No	Ramp Slope (%)	10.6
No	Ramp Width (in)	31.0	Yes	Ramp XSlope (%)	2.1
N/A	Flare Type LT	N/A	N/A	Flare Type RT	N/A
N/A	Flare Slope LT (%)	N/A	N/A	Flare Slope RT (%)	N/A
N/A	Flare Traversable LT?	N/A	N/A	Flare Traversable RT?	N/A
N/A	Landing Length (in)	N/A	N/A	DWS Provided?	N/A
N/A	Landing Width (in)	N/A	N/A	DWS Contrast?	N/A
N/A	Landing Slope (%)	N/A	N/A	DWS Length (in)	N/A
N/A	Landing X Slope (%)	N/A	N/A	DWS Full Width?	N/A
N/A	Landing Curb? (Y/N)	N/A	N/A	DWS Offset (in)	N/A
N/A	Shared Landing?	N/A			
N/A	Gutter Ponding?	N/A	N/A	Gutter Slope (%)	N/A
N/A	Gutter Lip Ht (in)	N/A	N/A	Gutter X Slope (%)	N/A
N/A	Painted X Walk1?	No	N/A	Painted X Walk2?	N/A
	X Walk 1 Direction	To E		X Walk 2 Direction	N/A
N/A	X Walk 1 Width (in)	N/A	N/A	X Walk 2 Width (in)	N/A
	X Walk 1 Slope (%)	4.5		X Walk 2 Slope (%)	N/A
	X Walk 1 X Slope (%)	3.1		X Walk 2 X Slope (%)	N/A

N/A	Ramp inside XWalk1?	N/A	N/A	Ramp inside XWalk2?	N/A
	Road Slope (%)	N/A	N/A	Clear Space?	N/A
	Road X Slope (%)	N/A	N/A	Clear Space to XWalk (in)	N/A
N/A	Any Obstructions?	N/A	N/A	Storm Grate/Utility Hazard?	N/A
	Obstruction Type			Storm Grate/Utility Type	
		N/A			N/A
			Yes	Surface Condition? (G/P)	Good

Possible Solutions:

Remove & Replace Entire Ramp.

R304.5.1, R304.2.2
