Access Compliance Report

Public Rights-of-Way

(Curb Ramps)

Intersection ID: 14706	Main Street: FULLIGER_ST	Cross Street: HIRAM_ST	Location: NW
ADA ID: 3BBFA7291737	Ramp Type: BlendTrans1	Initial Pass/Fail: Fail	Overall Compliance: No
		Severity Score: 10

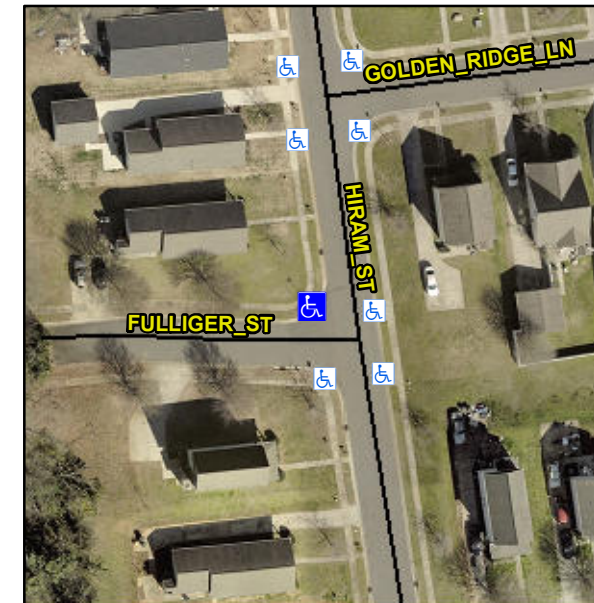
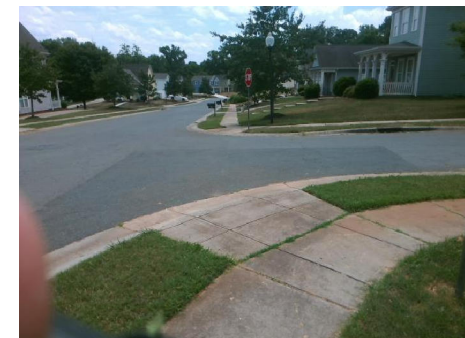
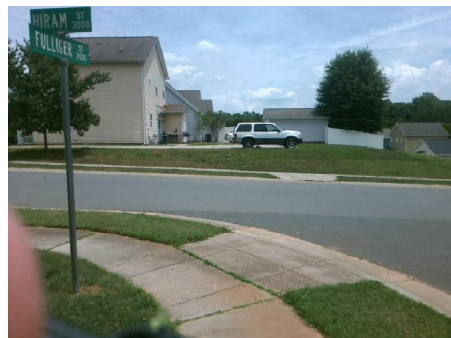
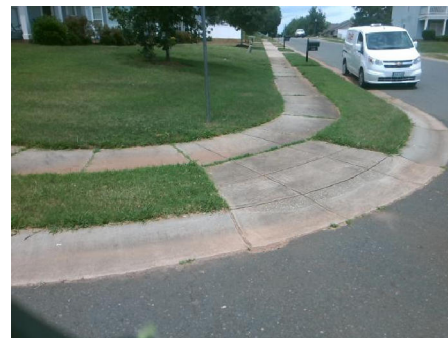
Not Found, R304.5.1, R304.5.3

Compliance	Description	Data	Compliance	Description	Data
N/A	Ramp Length (in)	54.0	Yes	BlendTrans Slope (%)	3.1
No	Ramp Width (in)	42.0	No	BlendTrans XSlope (%)	2.3
N/A	Flare Type LT	N/A	N/A	Flare Type RT	N/A
N/A	Flare Slope LT (%)	N/A	N/A	Flare Slope RT (%)	N/A
N/A	Flare Traversable LT?	N/A	N/A	Flare Traversable RT?	N/A
N/A	Landing Length (in)	N/A	N/A	DWS Provided?	N/A
N/A	Landing Width (in)	N/A	N/A	DWS Contrast?	N/A
N/A	Landing Slope (%)	N/A	N/A	DWS Length (in)	N/A
N/A	Landing X Slope (%)	N/A	N/A	DWS Full Width?	N/A
N/A	Landing Curb? (Y/N)	N/A	N/A	DWS Offset (in)	N/A
N/A	Shared Landing?	N/A			
N/A	Gutter Ponding?	N/A	N/A	Gutter Slope (%)	N/A
N/A	Gutter Lip Ht (in)	N/A	N/A	Gutter X Slope (%)	N/A
N/A	Painted X Walk1?	No	N/A	Painted X Walk2?	No
	X Walk 1 Direction	To E		X Walk 2 Direction	To S
	X Walk 1 Width (in)	N/A		X Walk 2 Width (in)	N/A
	X Walk 1 Slope (%)	3.7		X Walk 2 Slope (%)	2.5
	X Walk 1 X Slope (%)	2.1		X Walk 2 X Slope (%)	7.0

N/A	Ramp inside XWalk1?	N/A	N/A	Ramp inside XWalk2?	N/A
	Road Slope (%)	2.0		Clear Space?	N/A
	Road X Slope (%)	3.3	N/A	Clear Space to XWalk (in)	N/A
N/A	Any Obstructions?	N/A	N/A	Storm Grate/Utility Hazard?	N/A
	Obstruction Type			Storm Grate/Utility Type	
		N/A			N/A
			Yes	Surface Condition? (G/P)	Good
			No	Curb Slope (%)	9.7

Remove & Replace Curb Ramp With Two New Directional Ramps or Equivalent.
