# Access Compliance Report

## Public Rights-of-Way

### (Curb Ramps)

Intersection ID: 10025412	Main Street: E_CARSON_BV	Cross Street: N/A	Location:	N
ADA ID: 3BC610545ADE	Ramp Type: Perp	Initial Pass/Fail: Fail	Overall Compliance: No	Severity Score: 12.5
Codes/Mitigation Info/Possible Solution		Field Measurements/Component Compliance

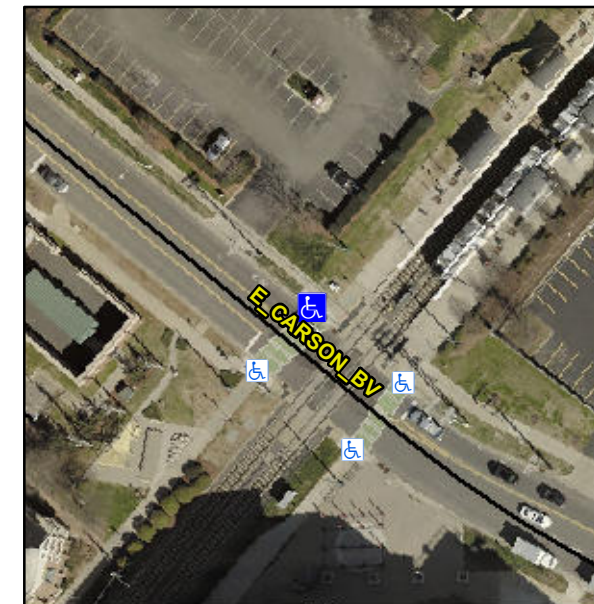
**Not Found, R304.2.2**

Compliance	Description	Data	Compliance	Description	Data
N/A	Ramp Length (in)	67.0	No	Ramp Slope (%)	8.6
Yes	Ramp Width (in)	98.0	Yes	Ramp XSlope (%)	0.4
N/A	Flare Type LT	N/A	N/A	Flare Type RT	N/A
N/A	Flare Slope LT (%)	N/A	N/A	Flare Slope RT (%)	N/A
N/A	Flare Traversable LT?	N/A	N/A	Flare Traversable RT?	N/A
N/A	Landing Length (in)	N/A	N/A	DWS Provided?	N/A
N/A	Landing Width (in)	N/A	N/A	DWS Contrast?	N/A
N/A	Landing Slope (%)	N/A	N/A	DWS Length (in)	N/A
N/A	Landing X Slope (%)	N/A	N/A	DWS Full Width?	N/A
N/A	Landing Curb? (Y/N)	N/A	N/A	DWS Offset (in)	N/A
N/A	Shared Landing?	N/A			
N/A	Gutter Ponding?	N/A	N/A	Gutter Slope (%)	N/A
N/A	Gutter Lip Ht (in)	N/A	N/A	Gutter X Slope (%)	N/A
N/A	Painted X Walk1?	Yes	N/A	Painted X Walk2?	N/A
	X Walk 1 Direction	To SW		X Walk 2 Direction	N/A
N/A	X Walk 1 Width (in)	161.0	N/A	X Walk 2 Width (in)	N/A
	X Walk 1 Slope (%)	2.9		X Walk 2 Slope (%)	N/A
	X Walk 1 X Slope (%)	0.6		X Walk 2 X Slope (%)	N/A

N/A	Ramp inside XWalk1?	Yes	N/A	Ramp inside XWalk2?	N/A
	Road Slope (%)	N/A	N/A	Clear Space?	N/A
	Road X Slope (%)	N/A	N/A	Clear Space to XWalk (in)	N/A
N/A	Any Obstructions?	N/A	N/A	Storm Grate/Utility Hazard?	N/A
	Obstruction Type			Storm Grate/Utility Type	
		N/A			N/A
			Yes	Surface Condition? (G/P)	Good

**Remove & Replace Entire Ramp.**
