Access Compliance Report

Public Rights-of-Way

(Curb Ramps)

Intersection ID: 49933	Main Street: MARVIN_RD	Cross Street: WOBURN_RD	Location: SE
ADA ID: 3BC81A370E4C	Ramp Type: Perp	Initial Pass/Fail: Fail	Overall Compliance: No
Severity Score: 8.75			
Codes/Mitigation Info/Possible Solution		Field Measurements/Component Compliance

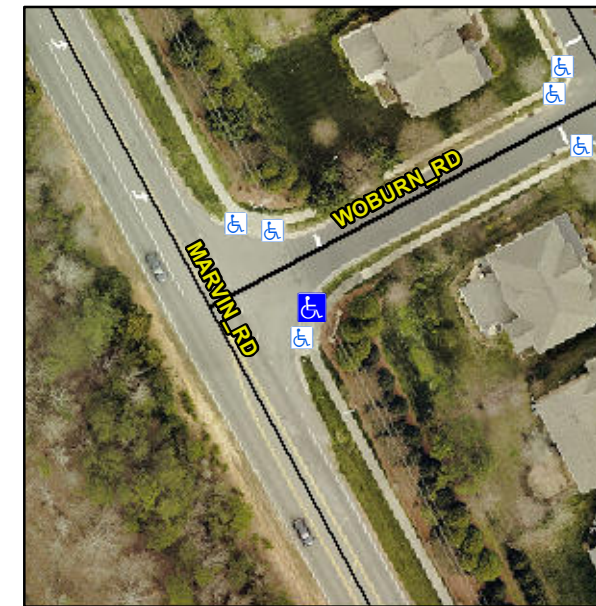
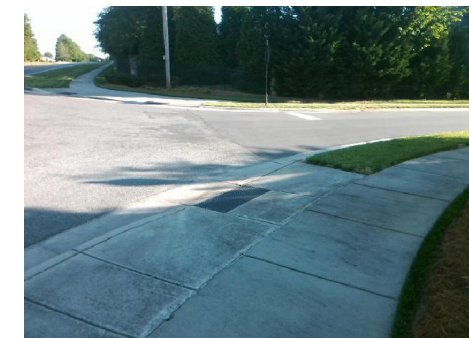
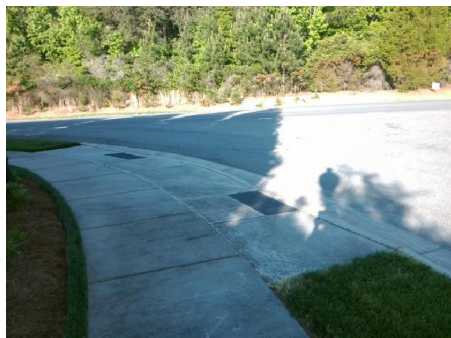
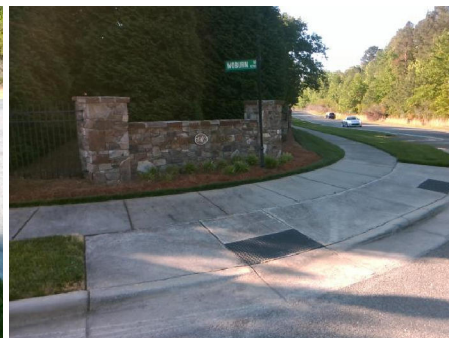
Not Found, R304.5.1

Compliance	Description	Data	Compliance	Description	Data
N/A	Ramp Length (in)	60.0	Yes	Ramp Slope (%)	5.1
No	Ramp Width (in)	46.0	Yes	Ramp XSlope (%)	0.1
N/A	Flare Type LT	N/A	N/A	Flare Type RT	N/A
N/A	Flare Slope LT (%)	N/A	N/A	Flare Slope RT (%)	N/A
N/A	Flare Traversable LT?	N/A	N/A	Flare Traversable RT?	N/A
N/A	Landing Length (in)	N/A	N/A	DWS Provided?	N/A
N/A	Landing Width (in)	N/A	N/A	DWS Contrast?	N/A
N/A	Landing Slope (%)	N/A	N/A	DWS Length (in)	N/A
N/A	Landing X Slope (%)	N/A	N/A	DWS Full Width?	N/A
N/A	Landing Curb? (Y/N)	N/A	N/A	DWS Offset (in)	N/A
N/A	Shared Landing?	N/A			
N/A	Gutter Ponding?	N/A	N/A	Gutter Slope (%)	N/A
N/A	Gutter Lip Ht (in)	N/A	N/A	Gutter X Slope (%)	N/A
N/A	Painted X Walk1?	No	N/A	Painted X Walk2?	N/A
	X Walk 1 Direction	To NW		X Walk 2 Direction	N/A
N/A	X Walk 1 Width (in)	N/A	N/A	X Walk 2 Width (in)	N/A
	X Walk 1 Slope (%)	7.2		X Walk 2 Slope (%)	N/A
	X Walk 1 X Slope (%)	2.7		X Walk 2 X Slope (%)	N/A

N/A	Ramp inside XWalk1?	N/A	N/A	Ramp inside XWalk2?	N/A
	Road Slope (%)	N/A	N/A	Clear Space?	N/A
	Road X Slope (%)	N/A	N/A	Clear Space to XWalk (in)	N/A
N/A	Any Obstructions?	N/A	N/A	Storm Grate/Utility Hazard?	N/A
	Obstruction Type			Storm Grate/Utility Type	
		N/A			N/A
			Yes	Surface Condition? (G/P)	Good

Remove & Replace Entire Ramp.
