Access Compliance Report

Public Rights-of-Way

(Curb Ramps)

Intersection ID: 12304	Main Street: COBBLERIDGE_DR	Cross Street: SHAMROCK_DR	Location: SW
ADA ID: 3BDF53A37F21	Ramp Type: PerpDiag	Initial Pass/Fail: Fail	Overall Compliance: No
		Severity Score: 22.5

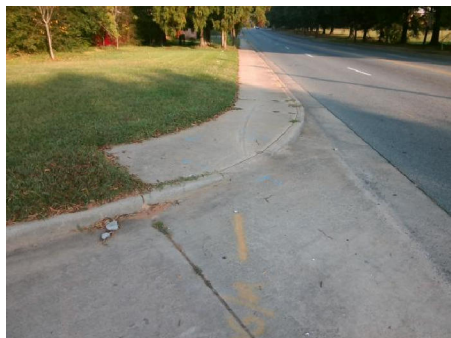
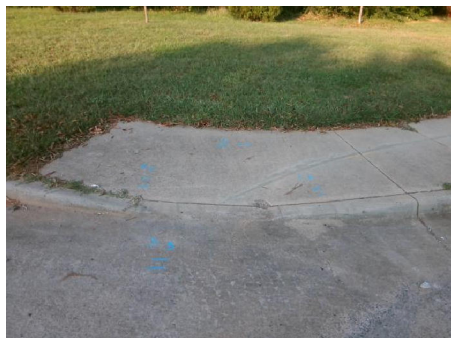
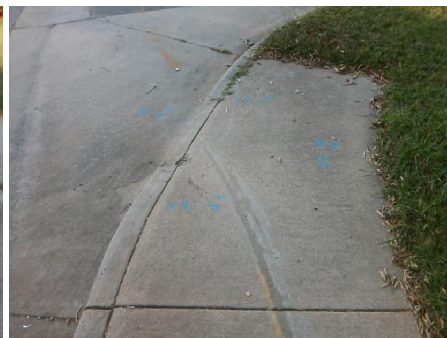
Not Found, R304.5.1, R304.2.2

Compliance	Description	Data	Compliance	Description	Data
N/A	Ramp Length (in)	58.5	No	Ramp Slope (%)	8.4
No	Ramp Width (in)	40.0	Yes	Ramp XSlope (%)	2.5
N/A	Flare Type LT	N/A	N/A	Flare Type RT	N/A
N/A	Flare Slope LT (%)	N/A	N/A	Flare Slope RT (%)	N/A
N/A	Flare Traversable LT?	N/A	N/A	Flare Traversable RT?	N/A
N/A	Landing Length (in)	N/A	N/A	DWS Provided?	N/A
N/A	Landing Width (in)	N/A	N/A	DWS Contrast?	N/A
N/A	Landing Slope (%)	N/A	N/A	DWS Length (in)	N/A
N/A	Landing X Slope (%)	N/A	N/A	DWS Full Width?	N/A
N/A	Landing Curb? (Y/N)	N/A	N/A	DWS Offset (in)	N/A
N/A	Shared Landing?	N/A			
N/A	Gutter Ponding?	N/A	N/A	Gutter Slope (%)	N/A
N/A	Gutter Lip Ht (in)	1.0	N/A	Gutter X Slope (%)	N/A
N/A	Painted X Walk1?	No	N/A	Painted X Walk2?	No
	X Walk 1 Direction	To SE		X Walk 2 Direction	To NE
N/A	X Walk 1 Width (in)	N/A	N/A	X Walk 2 Width (in)	N/A
	X Walk 1 Slope (%)	2.7		X Walk 2 Slope (%)	2.1
	X Walk 1 X Slope (%)	2.1		X Walk 2 X Slope (%)	1.5

N/A	Ramp inside XWalk1?	N/A	N/A	Ramp inside XWalk2?	N/A
	Road Slope (%)	3.8	N/A	Clear Space?	N/A
	Road X Slope (%)	1.1	N/A	Clear Space to XWalk (in)	N/A
N/A	Any Obstructions?	N/A	N/A	Storm Grate/Utility Hazard?	N/A
	Obstruction Type			Storm Grate/Utility Type	
		N/A			N/A
			Yes	Surface Condition? (G/P)	Good

Remove & Replace Curb Ramp With Two New Directional Ramps or Equivalent.
