Access Compliance Report

Public Rights-of-Way

(Curb Ramps)

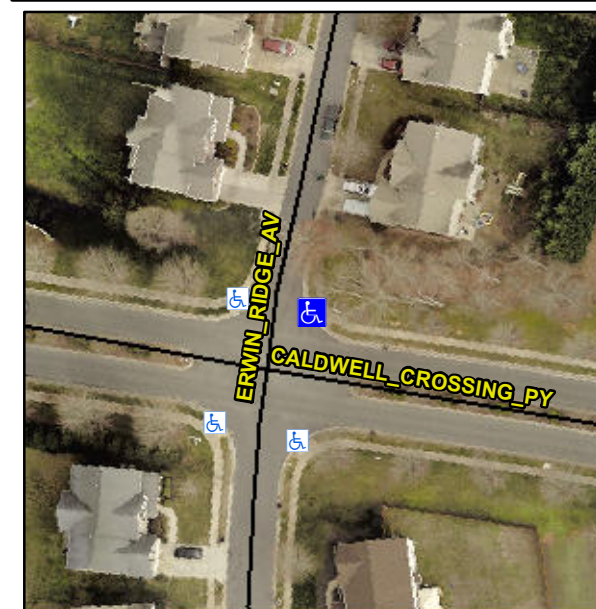
Intersection ID: 42790	Main Street: CALDWELL_CROSSING_PY	Cross Street: ERWIN_RIDGE_AV	Location: NE
ADA ID: 3BE443DC5986	Ramp Type: PerpDiag	Initial Pass/Fail: Fail	Overall Compliance: No
Severity Score: 21.25			
Codes/Mitigation Info/Possible Solution		Field Measurements/Component Compliance

Not Found, R304.5.1, R304.5.3

Compliance	Description	Data	Compliance	Description	Data
N/A	Ramp Length (in)	52.0	Yes	Ramp Slope (%)	6.5
No	Ramp Width (in)	39.0	No	Ramp XSlope (%)	5.6
N/A	Flare Type LT	N/A	N/A	Flare Type RT	N/A
N/A	Flare Slope LT (%)	N/A	N/A	Flare Slope RT (%)	N/A
N/A	Flare Traversable LT?	N/A	N/A	Flare Traversable RT?	N/A
N/A	Landing Length (in)	N/A	N/A	DWS Provided?	N/A
N/A	Landing Width (in)	N/A	N/A	DWS Contrast?	N/A
N/A	Landing Slope (%)	N/A	N/A	DWS Length (in)	N/A
N/A	Landing X Slope (%)	N/A	N/A	DWS Full Width?	N/A
N/A	Landing Curb? (Y/N)	N/A	N/A	DWS Offset (in)	N/A
N/A	Shared Landing?	N/A			
N/A	Gutter Ponding?	N/A	N/A	Gutter Slope (%)	N/A
N/A	Gutter Lip Ht (in)	N/A	N/A	Gutter X Slope (%)	N/A
N/A	Painted X Walk1?	No	N/A	Painted X Walk2?	No
	X Walk 1 Direction	To W		X Walk 2 Direction	To S
N/A	X Walk 1 Width (in)	N/A	N/A	X Walk 2 Width (in)	N/A
	X Walk 1 Slope (%)	0.9		X Walk 2 Slope (%)	7.2
	X Walk 1 X Slope (%)	5.5		X Walk 2 X Slope (%)	1.0

N/A	Ramp inside XWalk1?	N/A	N/A	Ramp inside XWalk2?	N/A
	Road Slope (%)	3.5	N/A	Clear Space?	N/A
	Road X Slope (%)	6.0	N/A	Clear Space to XWalk (in)	N/A
N/A	Any Obstructions?	N/A	N/A	Storm Grate/Utility Hazard?	N/A
	Obstruction Type			Storm Grate/Utility Type	
		N/A			N/A
		Yes		Surface Condition? (G/P)	Good

Possible Solutions:

Remove & Replace Curb Ramp With Two New Directional Ramps or Equivalent.
