# Access Compliance Report

## Public Rights-of-Way

### (Curb Ramps)

Intersection ID: N/A	Main Street: BILLY_GRAHAM_PY	Cross Street: TRYON_ST	Location: NW
ADA ID: 3BE4919B08E1	Ramp Type: PerpDiag	Initial Pass/Fail: Fail	Overall Compliance: No
			Severity Score: 26.25

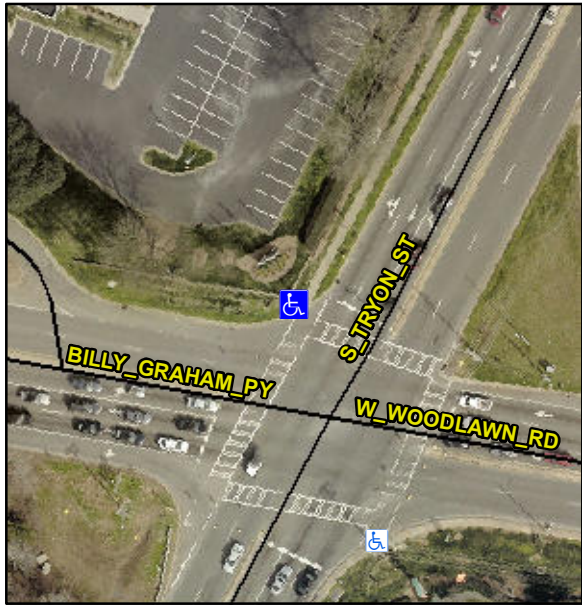
Possible Solutions:		Compliance	Description	Data	Compliance	Description	Data
	Remove & Replace Curb Ramp With Two New Directional Ramps or Equivalent.		N/A	Ramp Length (in)	58.0	No	Ramp Slope (%)	12.4
			Yes	Ramp Width (in)	48.0	No	Ramp XSlope (%)	4.4
			N/A	Flare Type LT	N/A	N/A	Flare Type RT	N/A
			N/A	Flare Slope LT (%)	N/A	N/A	Flare Slope RT (%)	N/A
			N/A	Flare Traversable LT?	N/A	N/A	Flare Traversable RT?	N/A
			N/A	Landing Length (in)	N/A	N/A	DWS Provided?	N/A
			N/A	Landing Width (in)	N/A	N/A	DWS Contrast?	N/A
			N/A	Landing Slope (%)	N/A	N/A	DWS Length (in)	N/A
			N/A	Landing X Slope (%)	N/A	N/A	DWS Full Width?	N/A
Surveyor Notes:	N/A		N/A	Landing Curb? (Y/N)	N/A	N/A	DWS Offset (in)	N/A
			N/A	Shared Landing?	N/A			
			N/A	Gutter Ponding?	N/A	N/A	Gutter Slope (%)	N/A
			N/A	Gutter Lip Ht (in)	N/A	N/A	Gutter X Slope (%)	N/A

N/A	Painted X Walk1?	Yes	N/A	Painted X Walk2?	Yes
				X Walk 1 Direction	To SW		X Walk 2 Direction	To SE
			N/A	X Walk 1 Width (in)	110.0	N/A	X Walk 2 Width (in)	110.0
				X Walk 1 Slope (%)	0.3		X Walk 2 Slope (%)	2.9
				X Walk 1 X Slope (%)	2.5		X Walk 2 X Slope (%)	1.2
			N/A	Ramp inside XWalk1?	Yes	N/A	Ramp inside XWalk2?	Yes
PROW/ADA:	Not Found, R304.2.2, R304.5.3			Road Slope (%)	2.5	N/A	Clear Space?	N/A
				Road X Slope (%)	1.6	N/A	Clear Space to XWalk (in)	N/A
			N/A	Any Obstructions?	N/A	N/A	Storm Grate/Utility Hazard?	N/A
				Obstruction Type			Storm Grate/Utility Type	
					N/A			N/A
						Yes	Surface Condition? (G/P)	Good
Total Cost:		\$ 3200.00
