## Access Compliance Report Public Rights-of-Way (Curb Ramps)

Intersection ID: 16439Main Street:SOUTH\_BVCross Street:SCALEYBARK\_RDLocation:NWADA ID: 3BEF5BCDE5D1Ramp Type:ParaInitial Pass/Fail:FailOverall Compliance:NoSeverity Score:13.75

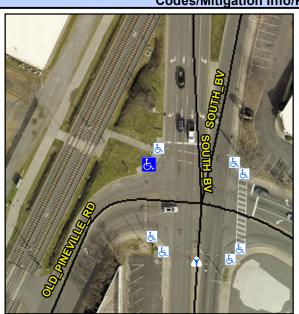
Field Measurements/Component Compliance							
Compliance Description		Data	Compliance Description		Data		
N/A	Ramp Length LT (in)	58.0	N/A	Ramp Length RT (in)	62.0		
Yes	Ramp Width LT (in)	72.0	Yes	Ramp Width RT (in)	72.0		
Yes	Ramp Slope LT (%)	5.8	No	Ramp Slope RT (%)	10.6		
No	Ramp XSlope LT (%)	2.3	No	Ramp XSlope RT (%)	2.7		
N/A	Landing Length (in)	N/A	N/A	DWS Provided?	N/A		
N/A	Landing Width (in)	N/A	N/A	DWS Contrast?	N/A		
N/A	Landing Slope (%)	N/A	N/A	DWS Length (in)	N/A		
N/A	Landing X Slope (%)	N/A	N/A	DWS Full Width?	N/A		
N/A	Landing Curb? (Y/N)	N/A	N/A	DWS Offset (in)	N/A		
N/A	Shared Landing?	N/A					
N/A	Gutter Ponding?	N/A	N/A	Gutter Slope (%)	N/A		
N/A	Gutter Lip Ht (in)	N/A	N/A	Gutter X Slope (%)	N/A		
N/A	Painted X Walk1?	Yes	N/A	Painted X Walk2?	N/A		
	X Walk 1 Direction	To S		X Walk 2 Direction	N/A		
N/A	X Walk 1 Width (in)	122.0	N/A	X Walk 2 Width (in)	N/A		
	X Walk 1 Slope (%)	1.4		X Walk 2 Slope (%)	N/A

X Walk 1 X Slope (%)	1.7		X Walk 2 X Slope (%)	N/A		
N/A	Ramp inside XWalk1?	Yes	N/A	Ramp inside XWalk2?	N/A		
	Road Slope (%)	N/A	N/A	Clear Space?	N/A		
	Road X Slope (%)	N/A	N/A	Clear Space to XWalk (in)	N/A		
N/A	Any Obstructions?	N/A	N/A	Storm Grate/Utility Hazard?	N/A		
	Obstruction Type			Storm Grate/Utility Type			
		N/A			N/A		
			Yes	Surface Condition? (G/P)	Good		
			N/A	Curb Slope (%)	11.8		
1	The state of the s

Remove & Replace Entire Ramp.

R304.5.3, R304.3.2
