Access Compliance Report

Public Rights-of-Way

(Curb Ramps)

Intersection ID: N/A	Main Street: YORKDALE_DR	Cross Street: MIDLOTHIAN_CT	Location: SE
ADA ID: 3BFDD3128EC4	Ramp Type: Perp	Initial Pass/Fail: Fail	Overall Compliance: No
		Severity Score: 12.5

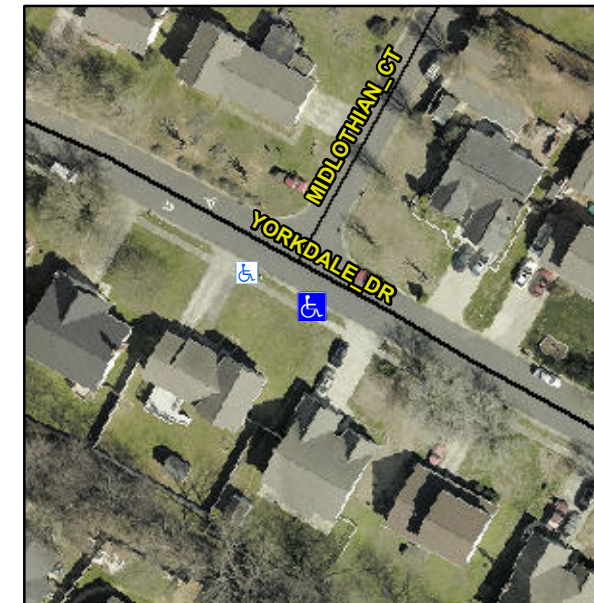
Compliance	Description	Data	Compliance	Description	Data
N/A	Ramp Length (in)	46.0	No	Ramp Slope (%)	11.1
Yes	Ramp Width (in)	97.0	Yes	Ramp XSlope (%)	1.4
N/A	Flare Type LT	N/A	N/A	Flare Type RT	N/A
N/A	Flare Slope LT (%)	N/A	N/A	Flare Slope RT (%)	N/A
N/A	Flare Traversable LT?	N/A	N/A	Flare Traversable RT?	N/A
N/A	Landing Length (in)	N/A	N/A	DWS Provided?	N/A
N/A	Landing Width (in)	N/A	N/A	DWS Contrast?	N/A
N/A	Landing Slope (%)	N/A	N/A	DWS Length (in)	N/A
N/A	Landing X Slope (%)	N/A	N/A	DWS Full Width?	N/A
N/A	Landing Curb? (Y/N)	N/A	N/A	DWS Offset (in)	N/A
N/A	Shared Landing?	N/A			
N/A	Gutter Ponding?	N/A	N/A	Gutter Slope (%)	N/A
N/A	Gutter Lip Ht (in)	N/A	N/A	Gutter X Slope (%)	N/A
N/A	Painted X Walk1?	No	N/A	Painted X Walk2?	N/A
	X Walk 1 Direction	To NE		X Walk 2 Direction	N/A
N/A	X Walk 1 Width (in)	N/A	N/A	X Walk 2 Width (in)	N/A
	X Walk 1 Slope (%)	5.5		X Walk 2 Slope (%)	N/A
	X Walk 1 X Slope (%)	3.2		X Walk 2 X Slope (%)	N/A

N/A	Ramp inside XWalk1?	N/A	N/A	Ramp inside XWalk2?	N/A
	Road Slope (%)	N/A	N/A	Clear Space?	N/A
	Road X Slope (%)	N/A	N/A	Clear Space to XWalk (in)	N/A
N/A	Any Obstructions?	N/A	N/A	Storm Grate/Utility Hazard?	N/A
	Obstruction Type			Storm Grate/Utility Type	
		N/A			N/A
			Yes	Surface Condition? (G/P)	Good

Possible Solutions:

Remove & Replace Entire Ramp.

R304.2.2

\$ 1850.00
