Intersection ID: 11006	Main Street: WESTBROOK_DR	Cross Street: WOODVALE_PL	Location:	S
ADA ID: 3C0ADB2D6A22	Ramp Type: PerpDiag	Initial Pass/Fail: Fail	Overall Compliance: No	Severity Score: 35

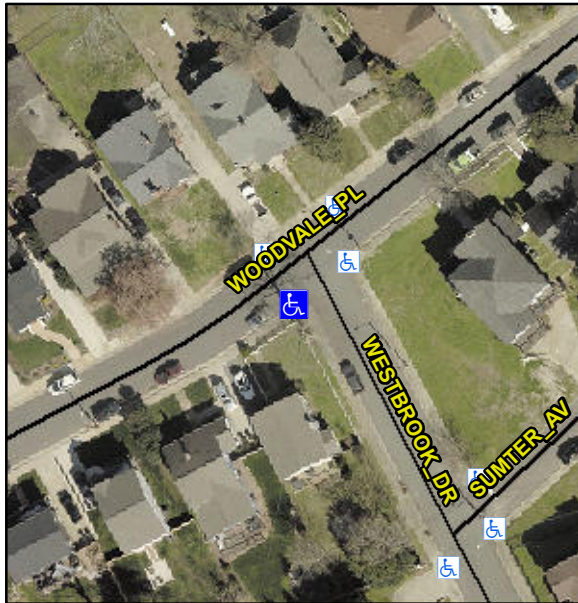
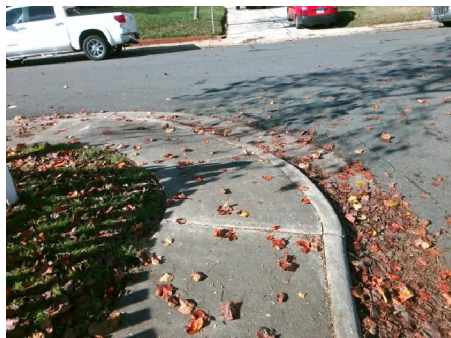
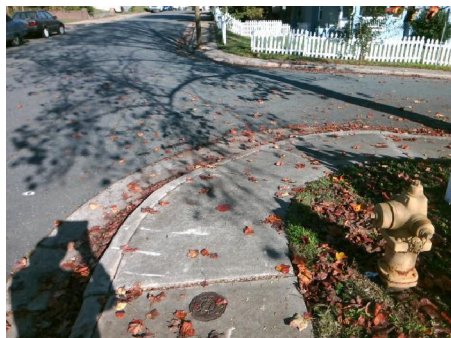
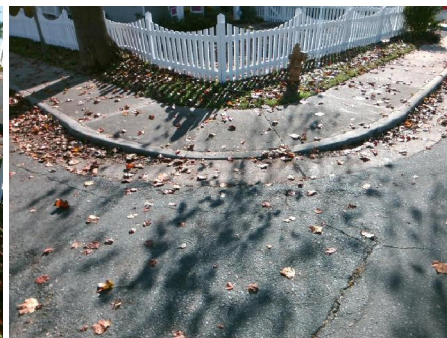
**Not Found, R304.5.1**

Compliance	Description	Data	Compliance	Description	Data
N/A	Ramp Length (in)	48.0	Yes	Ramp Slope (%)	8.0
No	Ramp Width (in)	26.0	Yes	Ramp XSlope (%)	0.2
N/A	Flare Type LT	N/A	N/A	Flare Type RT	N/A
N/A	Flare Slope LT (%)	N/A	N/A	Flare Slope RT (%)	N/A
N/A	Flare Traversable LT?	N/A	N/A	Flare Traversable RT?	N/A
N/A	Landing Length (in)	N/A	N/A	DWS Provided?	N/A
N/A	Landing Width (in)	N/A	N/A	DWS Contrast?	N/A
N/A	Landing Slope (%)	N/A	N/A	DWS Length (in)	N/A
N/A	Landing X Slope (%)	N/A	N/A	DWS Full Width?	N/A
N/A	Landing Curb? (Y/N)	N/A	N/A	DWS Offset (in)	N/A
N/A	Shared Landing?	N/A			
N/A	Gutter Ponding?	N/A	N/A	Gutter Slope (%)	N/A
N/A	Gutter Lip Ht (in)	0.5	N/A	Gutter X Slope (%)	N/A
N/A	Painted X Walk1?	No	N/A	Painted X Walk2?	No
	X Walk 1 Direction	To NE		X Walk 2 Direction	To NW
N/A	X Walk 1 Width (in)	N/A	N/A	X Walk 2 Width (in)	N/A
	X Walk 1 Slope (%)	5.6		X Walk 2 Slope (%)	5.4
	X Walk 1 X Slope (%)	5.0		X Walk 2 X Slope (%)	7.5

N/A	Ramp inside XWalk1?	N/A	N/A	Ramp inside XWalk2?	N/A
	Road Slope (%)	4.1	N/A	Clear Space?	N/A
	Road X Slope (%)	10.6	N/A	Clear Space to XWalk (in)	N/A
N/A	Any Obstructions?	N/A	N/A	Storm Grate/Utility Hazard?	N/A
	Obstruction Type			Storm Grate/Utility Type	
		N/A			N/A
			Yes	Surface Condition? (G/P)	Good

**Remove & Replace Curb Ramp With Two New Directional Ramps or Equivalent.**
