Access Compliance Report

Public Rights-of-Way

(Curb Ramps)

Intersection ID: 44420	Main Street: PROVIDENCE PROMENADE DR S	Cross Street: PROVIDENCE PROMENADE DR S	Location: SE
ADA ID: 3C1219CB39D3	Ramp Type: Perp	Initial Pass/Fail: Fail	Overall Compliance: No
Severity Score: 12.5			
Codes/Mitigation Info/Possible Solution		Field Measurements/Component Compliance

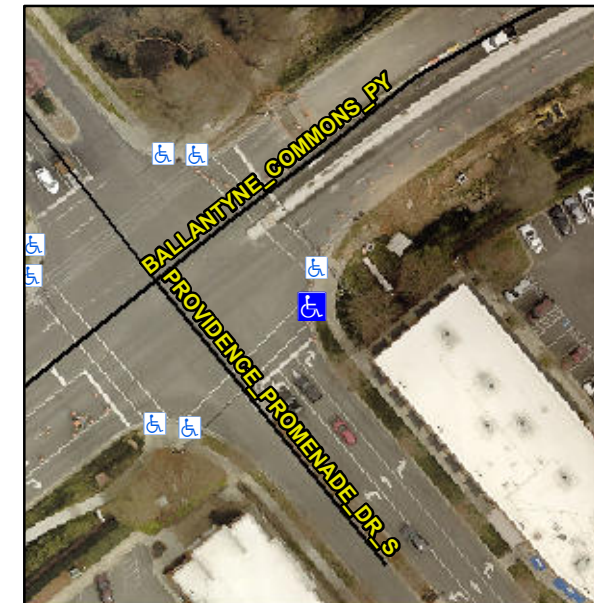
Not Found, R304.5.3

Compliance	Description	Data	Compliance	Description	Data
N/A	Ramp Length (in)	72.0	Yes	Ramp Slope (%)	5.2
Yes	Ramp Width (in)	51.0	No	Ramp XSlope (%)	5.4
N/A	Flare Type LT	N/A	N/A	Flare Type RT	N/A
N/A	Flare Slope LT (%)	N/A	N/A	Flare Slope RT (%)	N/A
N/A	Flare Traversable LT?	N/A	N/A	Flare Traversable RT?	N/A
N/A	Landing Length (in)	N/A	N/A	DWS Provided?	N/A
N/A	Landing Width (in)	N/A	N/A	DWS Contrast?	N/A
N/A	Landing Slope (%)	N/A	N/A	DWS Length (in)	N/A
N/A	Landing X Slope (%)	N/A	N/A	DWS Full Width?	N/A
N/A	Landing Curb? (Y/N)	N/A	N/A	DWS Offset (in)	N/A
N/A	Shared Landing?	N/A			
N/A	Gutter Ponding?	N/A	N/A	Gutter Slope (%)	N/A
N/A	Gutter Lip Ht (in)	N/A	N/A	Gutter X Slope (%)	N/A
N/A	Painted X Walk1?	Yes	N/A	Painted X Walk2?	N/A
	X Walk 1 Direction	To SW		X Walk 2 Direction	N/A
N/A	X Walk 1 Width (in)	113.0	N/A	X Walk 2 Width (in)	N/A
	X Walk 1 Slope (%)	2.0		X Walk 2 Slope (%)	N/A
	X Walk 1 X Slope (%)	3.5		X Walk 2 X Slope (%)	N/A

N/A	Ramp inside XWalk1?	Yes	N/A	Ramp inside XWalk2?	N/A
	Road Slope (%)	N/A	N/A	Clear Space?	N/A
	Road X Slope (%)	N/A	N/A	Clear Space to XWalk (in)	N/A
N/A	Any Obstructions?	N/A	N/A	Storm Grate/Utility Hazard?	N/A
	Obstruction Type			Storm Grate/Utility Type	
		N/A			N/A
		Yes		Surface Condition? (G/P)	Good

Remove & Replace Entire Ramp.
