# Access Compliance Report

## Public Rights-of-Way

### (Curb Ramps)

Intersection ID: 30049	Main Street: SUMMER_COACH_DR	Cross Street: SUNSET_VILLAGE_DR	Location: E
ADA ID: 3C192A8C57A0	Ramp Type: Perp	Initial Pass/Fail: Fail	Overall Compliance: No
		Severity Score: 12.5

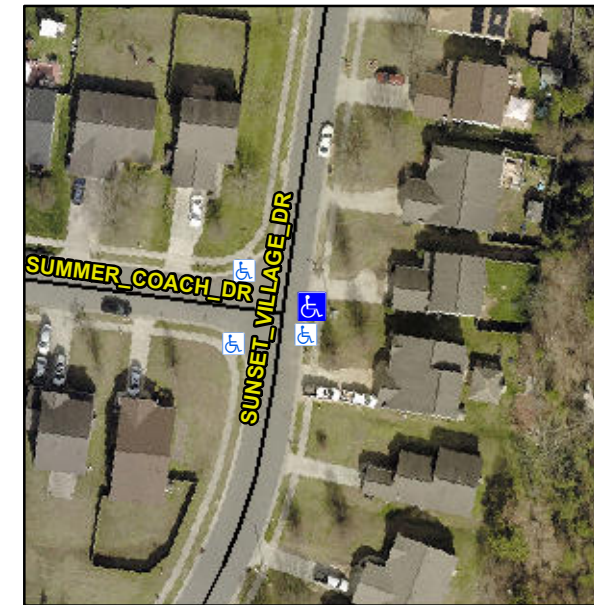
**Not Found, R304.5.3**

Compliance	Description	Data	Compliance	Description	Data
N/A	Ramp Length (in)	48.0	Yes	Ramp Slope (%)	6.4
Yes	Ramp Width (in)	48.0	No	Ramp XSlope (%)	5.3
N/A	Flare Type LT	N/A	N/A	Flare Type RT	N/A
N/A	Flare Slope LT (%)	N/A	N/A	Flare Slope RT (%)	N/A
N/A	Flare Traversable LT?	N/A	N/A	Flare Traversable RT?	N/A
N/A	Landing Length (in)	N/A	N/A	DWS Provided?	N/A
N/A	Landing Width (in)	N/A	N/A	DWS Contrast?	N/A
N/A	Landing Slope (%)	N/A	N/A	DWS Length (in)	N/A
N/A	Landing X Slope (%)	N/A	N/A	DWS Full Width?	N/A
N/A	Landing Curb? (Y/N)	N/A	N/A	DWS Offset (in)	N/A
N/A	Shared Landing?	N/A			
N/A	Gutter Ponding?	N/A	N/A	Gutter Slope (%)	N/A
N/A	Gutter Lip Ht (in)	N/A	N/A	Gutter X Slope (%)	N/A
N/A	Painted X Walk1?	No	N/A	Painted X Walk2?	N/A
	X Walk 1 Direction	To NW		X Walk 2 Direction	N/A
N/A	X Walk 1 Width (in)	N/A	N/A	X Walk 2 Width (in)	N/A
	X Walk 1 Slope (%)	2.7		X Walk 2 Slope (%)	N/A
	X Walk 1 X Slope (%)	7.9		X Walk 2 X Slope (%)	N/A

N/A	Ramp inside XWalk1?	N/A	N/A	Ramp inside XWalk2?	N/A
	Road Slope (%)	N/A	N/A	Clear Space?	N/A
	Road X Slope (%)	N/A	N/A	Clear Space to XWalk (in)	N/A
N/A	Any Obstructions?	N/A	N/A	Storm Grate/Utility Hazard?	N/A
	Obstruction Type			Storm Grate/Utility Type	
		N/A			N/A
			Yes	Surface Condition? (G/P)	Good

**Remove & Replace Entire Ramp.**
