# Access Compliance Report

## Public Rights-of-Way

### (Curb Ramps)

Intersection ID: 12048	Main Street: S_GRAHAM_ST	Cross Street: W_3RD_ST	Location:	N
ADA ID: 3C193886FD62	Ramp Type: Directional1	Initial Pass/Fail: Fail	Overall Compliance: No	Severity Score: 12.5
Codes/Mitigation Info/Possible Solution		Field Measurements/Component Compliance

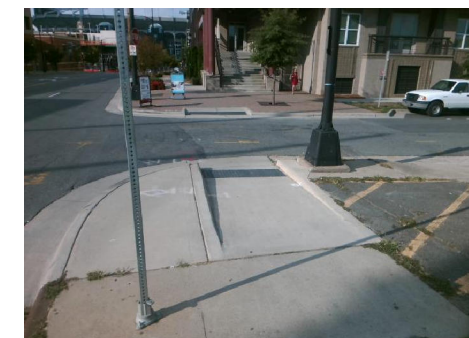
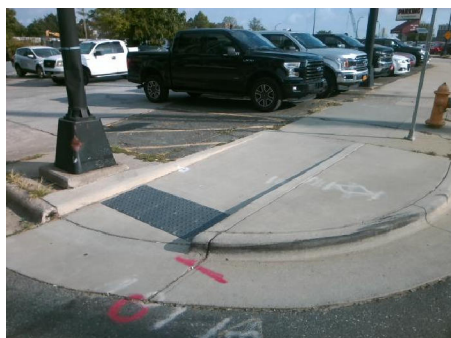
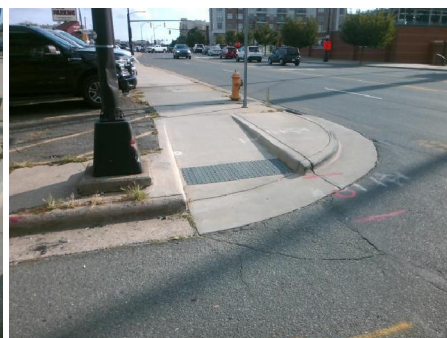
Compliance	Description	Data	Compliance	Description	Data
N/A	Ramp Length (in)	144.0	N/A	Grade Break?	N/A
Yes	Ramp Width (in)	61.0	N/A	Grade Break Slope (%)	0.0
No	Ramp Slope (%)	9.9	N/A	Grade Break XSlope (%)	0.0
Yes	Ramp XSlope (%)	0.8			
N/A	Flare Type LT	N/A	N/A	Flare Type RT	N/A
N/A	Flare Slope LT (%)	N/A	N/A	Flare Slope RT (%)	0.0
N/A	Flare Traversable LT?	N/A	N/A	Flare Traversable RT?	N/A
N/A	Landing Length (in)	0.0	N/A	DWS Provided?	N/A
N/A	Landing Width (in)	0.0	N/A	DWS Contrast?	N/A
N/A	Landing Slope (%)	0.0	N/A	DWS Length (in)	N/A
N/A	Landing X Slope (%)	0.0	N/A	DWS Full Width?	N/A
N/A	Landing Curb? (Y/N)	N/A	N/A	DWS Offset LT (in)	N/A
N/A	Shared Landing?	N/A	N/A	DWS Offset RT (in)	N/A
N/A	Gutter Ponding?	0.0	N/A	Gutter Slope (%)	N/A
N/A	Gutter Lip Ht (in)	0.0	N/A	Gutter X Slope (%)	N/A
N/A	Painted X Walk1?	No		Road Slope (%)	2.3
	X Walk 1 Direction	To SW		Road X Slope (%)	4.7
	X Walk 1 Width (in)	N/A		Clear Space?	N/A

X Walk 1 Slope (%)	2.3	N/A	Clear Space to XWalk (in)	N/A
	X Walk 1 X Slope (%)	4.7	N/A	Storm Grate/Utility Hazard?	N/A
N/A	Ramp inside XWalk1?	N/A		Storm Grate/Utility Type	
N/A	Any Obstructions?	N/A			N/A
	Obstruction Type		Yes	Surface Condition? (G/P)	Good
			N/A	Curb Slope (%)	8.5

Possible Solutions:

**Remove & Replace Entire Ramp.**

**R304.2.2**

\$ 1600.00
