Access Compliance Report

Public Rights-of-Way

(Curb Ramps)

Intersection ID: 11436	Main Street: E_19TH_ST	Cross Street: N_DAVIDSON_ST	Location: E
ADA ID: 3C22635BF28B	Ramp Type: PerpDiag	Initial Pass/Fail: Fail	Overall Compliance: No
			Severity Score: 13.75

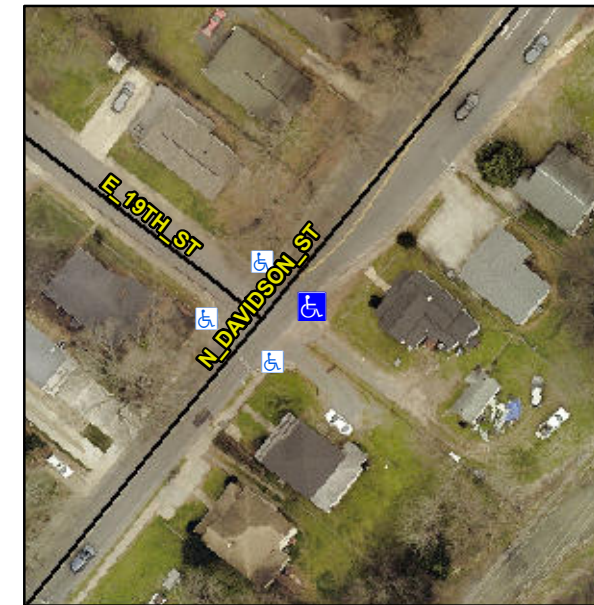
Compliance	Description	Data	Compliance	Description	Data
N/A	Ramp Length (in)	48.0	No	Ramp Slope (%)	11.5
Yes	Ramp Width (in)	48.0	Yes	Ramp XSlope (%)	2.4
N/A	Flare Type LT	N/A	N/A	Flare Type RT	N/A
N/A	Flare Slope LT (%)	N/A	N/A	Flare Slope RT (%)	N/A
N/A	Flare Traversable LT?	N/A	N/A	Flare Traversable RT?	N/A
N/A	Landing Length (in)	N/A	N/A	DWS Provided?	N/A
N/A	Landing Width (in)	N/A	N/A	DWS Contrast?	N/A
N/A	Landing Slope (%)	N/A	N/A	DWS Length (in)	N/A
N/A	Landing X Slope (%)	N/A	N/A	DWS Full Width?	N/A
N/A	Landing Curb? (Y/N)	N/A	N/A	DWS Offset (in)	N/A
N/A	Shared Landing?	N/A			
N/A	Gutter Ponding?	Yes	N/A	Gutter Slope (%)	N/A
N/A	Gutter Lip Ht (in)	N/A	N/A	Gutter X Slope (%)	N/A
N/A	Painted X Walk1?	No	N/A	Painted X Walk2?	No
	X Walk 1 Direction	To NW		X Walk 2 Direction	To SW
N/A	X Walk 1 Width (in)	N/A	N/A	X Walk 2 Width (in)	N/A
	X Walk 1 Slope (%)	3.1		X Walk 2 Slope (%)	2.2
	X Walk 1 X Slope (%)	0.5		X Walk 2 X Slope (%)	0.4

N/A	Ramp inside XWalk1?	N/A	N/A	Ramp inside XWalk2?	N/A
	Road Slope (%)	3.9	N/A	Clear Space?	N/A
	Road X Slope (%)	2.1	N/A	Clear Space to XWalk (in)	N/A
N/A	Any Obstructions?	N/A	N/A	Storm Grate/Utility Hazard?	N/A
	Obstruction Type			Storm Grate/Utility Type	
		N/A			N/A
			Yes	Surface Condition? (G/P)	Good

Possible Solutions:

Remove & Replace Curb Ramp With Two New Directional Ramps or Equivalent.

Total Cost: \$ 3200.00
