# Access Compliance Report

## Public Rights-of-Way

### (Curb Ramps)

Intersection ID: 13683	Main Street: ELIZABETH_AV	Cross Street: CHARLOTTETOWNE_AV	Location: S
ADA ID: 3C2FFED9981C	Ramp Type: Perp	Initial Pass/Fail: Fail	Overall Compliance: No
Severity Score: 8.75			
Codes/Mitigation Info/Possible Solution		Field Measurements/Component Compliance

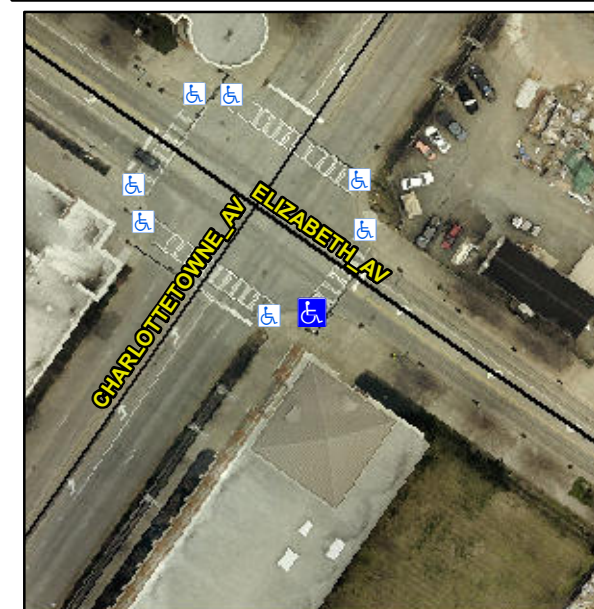
**Not Found, R304.5.1**

Compliance	Description	Data	Compliance	Description	Data
N/A	Ramp Length (in)	85.0	Yes	Ramp Slope (%)	7.9
No	Ramp Width (in)	47.5	Yes	Ramp XSlope (%)	1.9
N/A	Flare Type LT	N/A	N/A	Flare Type RT	N/A
N/A	Flare Slope LT (%)	N/A	N/A	Flare Slope RT (%)	N/A
N/A	Flare Traversable LT?	N/A	N/A	Flare Traversable RT?	N/A
N/A	Landing Length (in)	N/A	N/A	DWS Provided?	N/A
N/A	Landing Width (in)	N/A	N/A	DWS Contrast?	N/A
N/A	Landing Slope (%)	N/A	N/A	DWS Length (in)	N/A
N/A	Landing X Slope (%)	N/A	N/A	DWS Full Width?	N/A
N/A	Landing Curb? (Y/N)	N/A	N/A	DWS Offset (in)	N/A
N/A	Shared Landing?	N/A			
N/A	Gutter Ponding?	N/A	N/A	Gutter Slope (%)	N/A
N/A	Gutter Lip Ht (in)	N/A	N/A	Gutter X Slope (%)	N/A
N/A	Painted X Walk1?	Yes	N/A	Painted X Walk2?	N/A
	X Walk 1 Direction	To NE		X Walk 2 Direction	N/A
N/A	X Walk 1 Width (in)	106.0	N/A	X Walk 2 Width (in)	N/A
	X Walk 1 Slope (%)	0.2		X Walk 2 Slope (%)	N/A
	X Walk 1 X Slope (%)	2.7		X Walk 2 X Slope (%)	N/A

N/A	Ramp inside XWalk1?	Yes	N/A	Ramp inside XWalk2?	N/A
	Road Slope (%)	N/A	N/A	Clear Space?	N/A
	Road X Slope (%)	N/A	N/A	Clear Space to XWalk (in)	N/A
N/A	Any Obstructions?	N/A	N/A	Storm Grate/Utility Hazard?	N/A
	Obstruction Type			Storm Grate/Utility Type	
		N/A			N/A
		Yes		Surface Condition? (G/P)	Good

**Remove & Replace Entire Ramp.**

Total Cost: \$ 1850.00
