Access Compliance Report

Public Rights-of-Way

(Curb Ramps)

Intersection ID: 31386	Main Street: OAKDALE_RD	Cross Street: BRAVEHEART_LN	Location: SW
ADA ID: 3C341261F21E	Ramp Type: Combination1	Initial Pass/Fail: Fail	Overall Compliance: No
Severity Score: 21.25			
Codes/Mitigation Info/Possible Solution		Field Measurements/Component Compliance

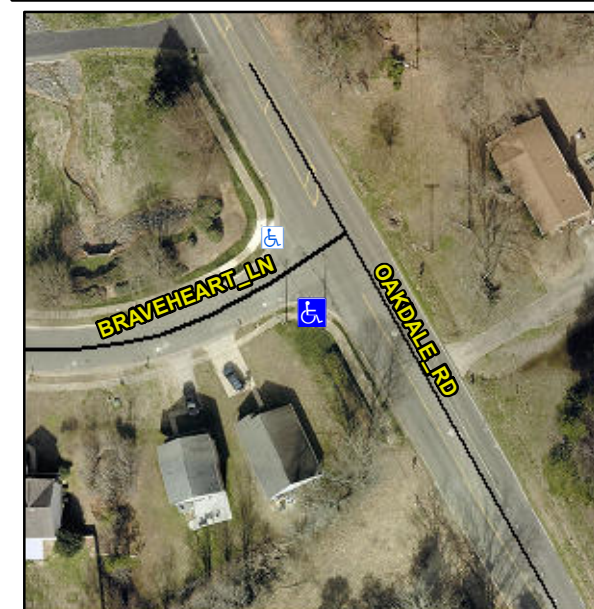
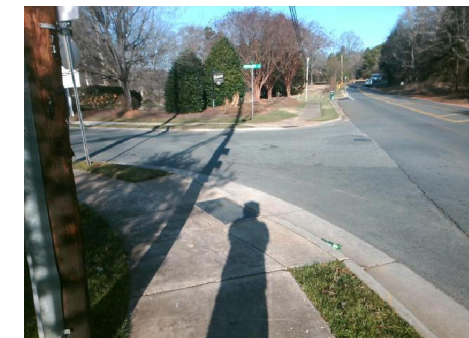
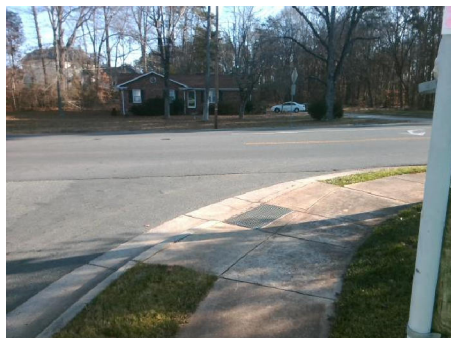
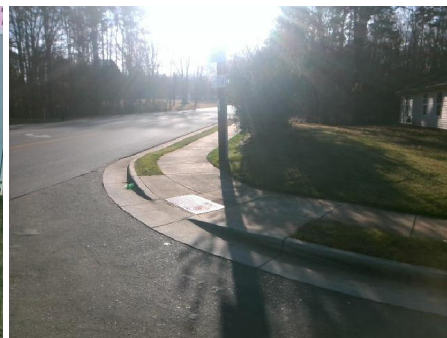
RP < 5%

Not Found, R304.5.1, R304.5.1, R304.3.2

Compliance	Description	Data	Compliance	Description	Data
N/A	Ramp Length LT (in)	53.0	N/A	Ramp Length RT (in)	56.0
Yes	Ramp Width LT (in)	50.0	No	Ramp Width RT (in)	46.0
No	Ramp Slope LT (%)	8.4	Yes	Ramp Slope RT (%)	7.5
Yes	Ramp XSlope LT (%)	0.3	Yes	Ramp XSlope RT (%)	1.1
N/A	Ramp Length (in)	38.0	Yes	Ramp Slope (%)	1.7
No	Ramp Width (in)	44.0	Yes	Ramp XSlope (%)	0.0
N/A	Flare Type LT	N/A	N/A	Flare Type RT	N/A
N/A	Flare Slope LT (%)	N/A	N/A	Flare Slope RT (%)	N/A
N/A	Flare Traversable LT?	N/A	N/A	Flare Traversable RT?	N/A
N/A	Landing Length (in)	N/A	N/A	DWS Provided?	N/A
N/A	Landing Width (in)	N/A	N/A	DWS Contrast?	N/A
N/A	Landing Slope (%)	N/A	N/A	DWS Length (in)	N/A
N/A	Landing X Slope (%)	N/A	N/A	DWS Full Width?	N/A
N/A	Landing Curb? (Y/N)	N/A	N/A	DWS Offset (in)	N/A
N/A	Shared Landing?	N/A			
N/A	Gutter Ponding?	N/A	N/A	Gutter Slope (%)	N/A
N/A	Gutter Lip Ht (in)	N/A	N/A	Gutter X Slope (%)	N/A
N/A	Painted X Walk1?	No	N/A	Painted X Walk2?	N/A

X Walk 1 Direction	To NW		X Walk 2 Direction	N/A
	X Walk 1 Width (in)	N/A		X Walk 2 Width (in)	N/A
	X Walk 1 Slope (%)	0.8		X Walk 2 Slope (%)	N/A
	X Walk 1 X Slope (%)	0.4		X Walk 2 X Slope (%)	N/A
N/A	Ramp inside XWalk1?	N/A	N/A	Ramp inside XWalk2?	N/A
	Road Slope (%)	N/A		Clear Space?	N/A
	Road X Slope (%)	N/A	N/A	Clear Space to XWalk (in)	N/A
			N/A	Any Obstruction?	N/A
				Obstruction Type	N/A
			N/A	Storm Grate/Utility Hazard?	N/A
				Storm Grate/Utility Type	N/A
Yes	Surface Condition? (G/P)	Good			
	Curb Slope (%)	11.0

Possible Solutions:

Remove & Replace Entire Ramp.
