Access Compliance Report

Public Rights-of-Way

(Curb Ramps)

Intersection ID: 42457	Main Street: SUNNINGHILL_PARK_RD	Cross Street: HONOR_GUARD_AV	Location: SE
ADA ID: 3C42DA3778F0	Ramp Type: Perp	Initial Pass/Fail: Fail	Overall Compliance: No
Severity Score: 37.5			
Codes/Mitigation Info/Possible Solution		Field Measurements/Component Compliance

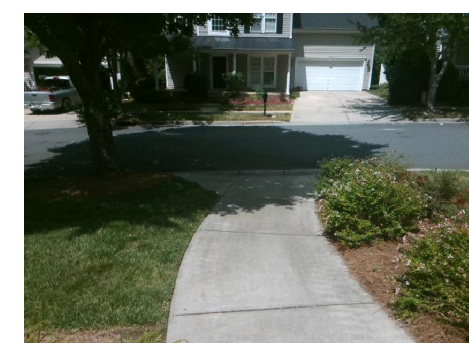
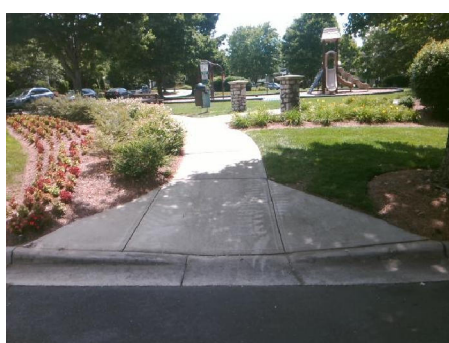
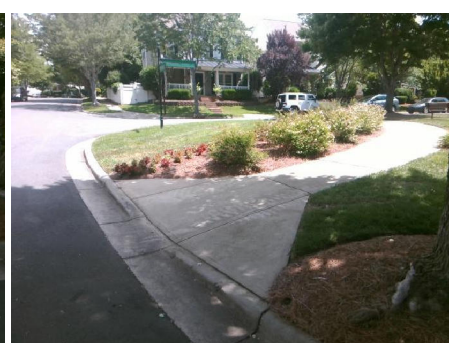
Compliance	Description	Data	Compliance	Description	Data
N/A	Ramp Length (in)	160.0	No	Ramp Slope (%)	16.9
Yes	Ramp Width (in)	48.0	No	Ramp XSlope (%)	6.5
N/A	Flare Type LT	N/A	N/A	Flare Type RT	N/A
N/A	Flare Slope LT (%)	N/A	N/A	Flare Slope RT (%)	N/A
N/A	Flare Traversable LT?	N/A	N/A	Flare Traversable RT?	N/A
N/A	Landing Length (in)	N/A	N/A	DWS Provided?	N/A
N/A	Landing Width (in)	N/A	N/A	DWS Contrast?	N/A
N/A	Landing Slope (%)	N/A	N/A	DWS Length (in)	N/A
N/A	Landing X Slope (%)	N/A	N/A	DWS Full Width?	N/A
N/A	Landing Curb? (Y/N)	N/A	N/A	DWS Offset (in)	N/A
N/A	Shared Landing?	N/A			
N/A	Gutter Ponding?	N/A	N/A	Gutter Slope (%)	N/A
N/A	Gutter Lip Ht (in)	N/A	N/A	Gutter X Slope (%)	N/A
N/A	Painted X Walk1?	No	N/A	Painted X Walk2?	N/A
	X Walk 1 Direction	To W		X Walk 2 Direction	N/A
N/A	X Walk 1 Width (in)	N/A	N/A	X Walk 2 Width (in)	N/A
	X Walk 1 Slope (%)	1.7		X Walk 2 Slope (%)	N/A
	X Walk 1 X Slope (%)	6.1		X Walk 2 X Slope (%)	N/A

N/A	Ramp inside XWalk1?	N/A	N/A	Ramp inside XWalk2?	N/A
	Road Slope (%)	N/A	N/A	Clear Space?	N/A
	Road X Slope (%)	N/A	N/A	Clear Space to XWalk (in)	N/A
N/A	Any Obstructions?	N/A	N/A	Storm Grate/Utility Hazard?	N/A
	Obstruction Type			Storm Grate/Utility Type	
		N/A			N/A
			Yes	Surface Condition? (G/P)	Good

Possible Solutions:

Remove & Replace Entire Ramp.

PROW/ADA:

R304.2.2, R304.5.3
