Access Compliance Report

Public Rights-of-Way

(Curb Ramps)

Intersection ID: 12779	Main Street: E_TRADE_ST	Cross Street: S_DAVIDSON_ST	Location: W
ADA ID: 3C4C1A6E09B7	Ramp Type: Perp	Initial Pass/Fail: Fail	Overall Compliance: No
			Severity Score: 13.75

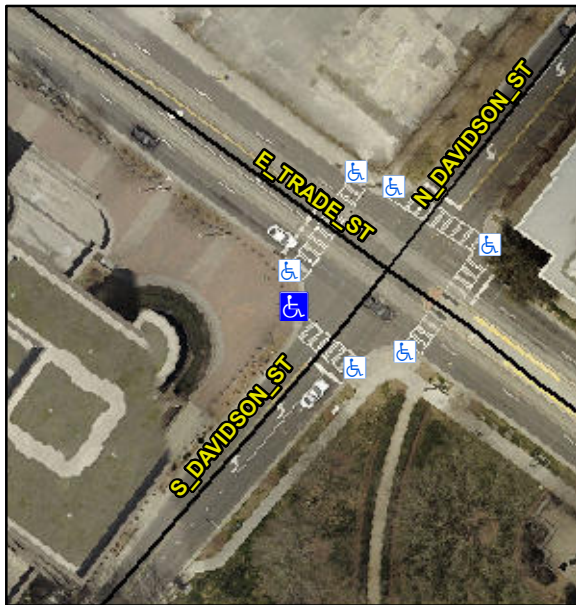
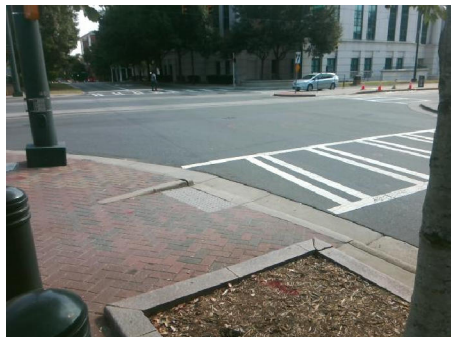
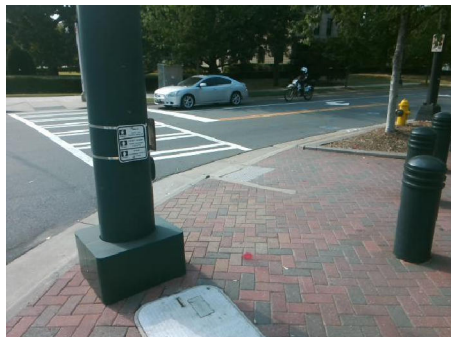
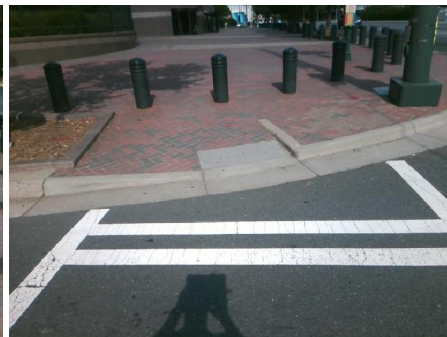
Not Found, R304.2.2

Compliance	Description	Data	Compliance	Description	Data
N/A	Ramp Length (in)	70.0	No	Ramp Slope (%)	9.1
Yes	Ramp Width (in)	48.0	Yes	Ramp XSlope (%)	2.1
N/A	Flare Type LT	N/A	N/A	Flare Type RT	N/A
N/A	Flare Slope LT (%)	N/A	N/A	Flare Slope RT (%)	N/A
N/A	Flare Traversable LT?	N/A	N/A	Flare Traversable RT?	N/A
N/A	Landing Length (in)	N/A	N/A	DWS Provided?	N/A
N/A	Landing Width (in)	N/A	N/A	DWS Contrast?	N/A
N/A	Landing Slope (%)	N/A	N/A	DWS Length (in)	N/A
N/A	Landing X Slope (%)	N/A	N/A	DWS Full Width?	N/A
N/A	Landing Curb? (Y/N)	N/A	N/A	DWS Offset (in)	N/A
N/A	Shared Landing?	N/A			
N/A	Gutter Ponding?	N/A	N/A	Gutter Slope (%)	N/A
N/A	Gutter Lip Ht (in)	N/A	N/A	Gutter X Slope (%)	N/A
N/A	Painted X Walk1?	Yes	N/A	Painted X Walk2?	N/A
	X Walk 1 Direction	To SE		X Walk 2 Direction	N/A
N/A	X Walk 1 Width (in)	118.0	N/A	X Walk 2 Width (in)	N/A
	X Walk 1 Slope (%)	2.5		X Walk 2 Slope (%)	N/A
	X Walk 1 X Slope (%)	2.1		X Walk 2 X Slope (%)	N/A

N/A	Ramp inside XWalk1?	Yes	N/A	Ramp inside XWalk2?	N/A
	Road Slope (%)	N/A	N/A	Clear Space?	N/A
	Road X Slope (%)	N/A	N/A	Clear Space to XWalk (in)	N/A
N/A	Any Obstructions?	N/A	N/A	Storm Grate/Utility Hazard?	N/A
	Obstruction Type			Storm Grate/Utility Type	
		N/A			N/A
			Yes	Surface Condition? (G/P)	Good

Remove & Replace Entire Ramp.

Total Cost: \$ 1850.00
