Access Compliance Report

Public Rights-of-Way

(Curb Ramps)

Intersection ID: 14061	Main Street: BARCLIFF_DR	Cross Street: LAWRENCE_ORR_RD	Location: NW
ADA ID: 3C537428B6B6	Ramp Type: PerpDiag	Initial Pass/Fail: Fail	Overall Compliance: No
Severity Score: 10			
Codes/Mitigation Info/Possible Solution		Field Measurements/Component Compliance

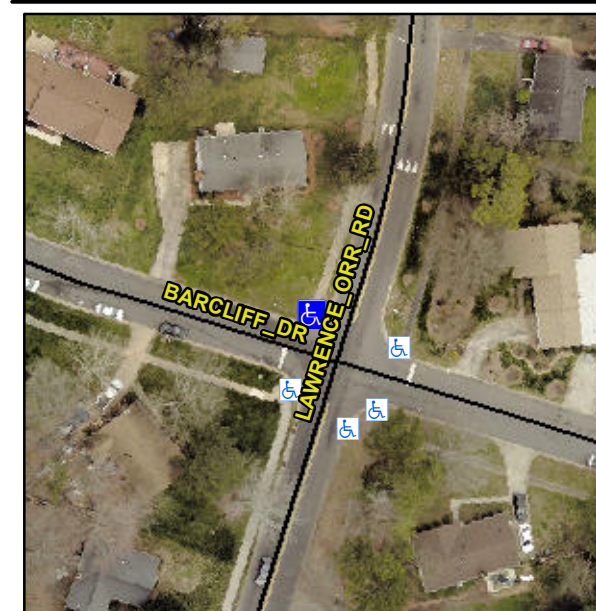
Not Found, R304.5.1, R304.5.3

Compliance	Description	Data	Compliance	Description	Data
N/A	Ramp Length (in)	50.0	Yes	Ramp Slope (%)	5.2
No	Ramp Width (in)	40.0	No	Ramp XSlope (%)	2.6
N/A	Flare Type LT	N/A	N/A	Flare Type RT	N/A
N/A	Flare Slope LT (%)	N/A	N/A	Flare Slope RT (%)	N/A
N/A	Flare Traversable LT?	N/A	N/A	Flare Traversable RT?	N/A
N/A	Landing Length (in)	N/A	N/A	DWS Provided?	N/A
N/A	Landing Width (in)	N/A	N/A	DWS Contrast?	N/A
N/A	Landing Slope (%)	N/A	N/A	DWS Length (in)	N/A
N/A	Landing X Slope (%)	N/A	N/A	DWS Full Width?	N/A
N/A	Landing Curb? (Y/N)	N/A	N/A	DWS Offset (in)	N/A
N/A	Shared Landing?	N/A			
N/A	Gutter Ponding?	N/A	N/A	Gutter Slope (%)	N/A
N/A	Gutter Lip Ht (in)	N/A	N/A	Gutter X Slope (%)	N/A
N/A	Painted X Walk1?	No	N/A	Painted X Walk2?	No
	X Walk 1 Direction	To SW		X Walk 2 Direction	To SE
N/A	X Walk 1 Width (in)	N/A	N/A	X Walk 2 Width (in)	N/A
	X Walk 1 Slope (%)	3.2		X Walk 2 Slope (%)	3.3
	X Walk 1 X Slope (%)	1.6		X Walk 2 X Slope (%)	2.0

N/A	Ramp inside XWalk1?	N/A	N/A	Ramp inside XWalk2?	N/A
	Road Slope (%)	2.5	N/A	Clear Space?	N/A
	Road X Slope (%)	3.1	N/A	Clear Space to XWalk (in)	N/A
N/A	Any Obstructions?	N/A	N/A	Storm Grate/Utility Hazard?	N/A
	Obstruction Type			Storm Grate/Utility Type	
		N/A			N/A
		Yes		Surface Condition? (G/P)	Good

Remove & Replace Curb Ramp With Two New Directional Ramps or Equivalent.
