# Access Compliance Report

## Public Rights-of-Way

### (Curb Ramps)

| Intersection ID: 10040926 | Main Street: WALLACE_RD | Cross Street: N/A | Location: S |

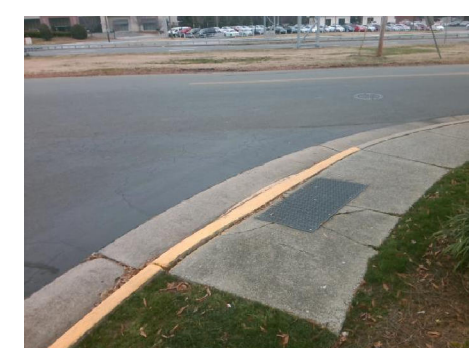
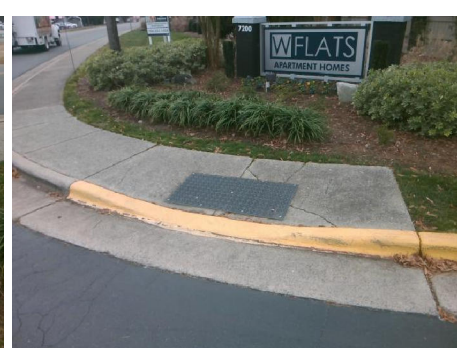
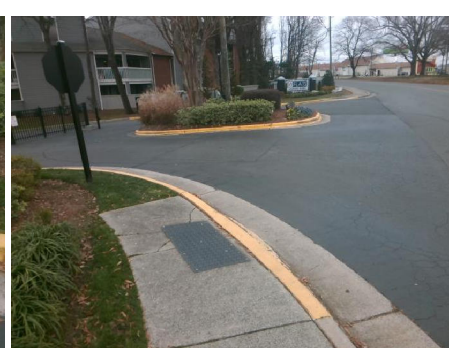
| ADA ID: 3C55D4CAEEA6 | Ramp Type: PerpDiag | Initial Pass/Fail: Fail | Overall Compliance: No |

| Codes/Mitigation Info/Possible Solution | | | Field Measurements/Component Compliance | | | | | |
|---|---|---|---|---|---|---|---|---|
| | <b>Remove &amp; Replace Curb Ramp With Two New Directional Ramps or Equivalent.</b> | | N/A | Ramp Length (in) | 48.0 | No | Ramp Slope (%) | 9.3 |
| | | | No | Ramp Width (in) | 43.0 | Yes | Ramp XSlope (%) | 1.4 |
| PROW/ADA: | | Not Found, R304.5.1, R304.2.2 | N/A | Shared Landing? | N/A | | | |

| Codes/Mitigation Info/Possible Solution | | | Field Measurements/Component Compliance | | | | | |
|---|---|---|---|---|---|---|---|---|
| | Possible Solutions: | | Compliance | Description | Data | Compliance | Description | Data |
| Total Cost: | | \$ 3200.00 | | | | | | |
