Access Compliance Report Public Rights-of-Way (Curb Ramps)

Intersection ID: 17967	Main Street: MONROE_RD			Street:	WALLACE_RD	Location:	SE		
ADA ID: 3C5B4984A958	A ID: 3C5B4984A958 Ramp Type: Perp		Initial	Initial Pass/Fail: Fail Overall Compliance: No				o Severity Score:	21.25
Codes/Mitigation Info/Possible Solution				Field Measurements/Component Compliance					
		Possible Solutions:		Compliance Description Data Compliance				liance Description	Data
	13 小小	Remove & Replace Entire Ram	р.	N/A	Ramp Length (in)	59.0	No	Ramp Slope (%)	10.4
	Contraction of the		•	No	Ramp Width (in)	47.0	Yes	Ramp XSlope (%)	1.1
				N/A	Flare Type LT	N/A	N/A	Flare Type RT	N/A
2 1 1 1	- Andrews	4		N/A	Flare Slope LT (%)	N/A	N/A	Flare Slope RT (%)	N/A
				N/A	Flare Traversable LT?	N/A	N/A	Flare Traversable RT?	N/A
				N/A	Landing Length (in)	N/A	N/A	DWS Provided?	N/A
		Surveyor Notes:		N/A	Landing Width (in)	N/A	N/A	DWS Contrast?	N/A
		N/A		N/A	Landing Slope (%)	N/A	N/A	DWS Length (in)	N/A

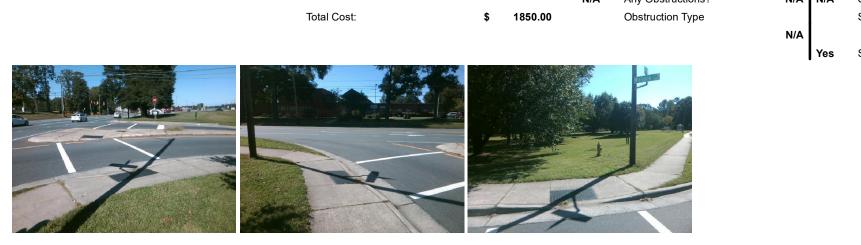
· 作品。"			N/A	Landing X Slope (%)	N/A	N/A	DWS Full Width?	N/A
	1. 1.			N/A	Landing Curb? (Y/N)	N/A	N/A	DWS Offset (in)	N/A
				N/A	Shared Landing?	N/A			
		PROW/ADA:		N/A	Gutter Ponding?	N/A	N/A	Gutter Slope (%)	N/A
		Not Found, R304.5.1, R304.2.2		N/A	Gutter Lip Ht (in)	N/A	N/A	Gutter X Slope (%)	N/A
				N/A	Painted X Walk1?	Yes	N/A	Painted X Walk2?	N/A
					X Walk 1 Direction	To NW		X Walk 2 Direction	N/A
		2		N/A	X Walk 1 Width (in)	114.0	N/A	X Walk 2 Width (in)	N/A
Street 1 Name W	ALLACE RD	_			X Walk 1 Slope (%)	4.2		X Walk 2 Slope (%)	N/A
Stop Condition-Street 2	None				X Walk 1 X Slope (%)	2.3		X Walk 2 X Slope (%)	N/A
Street 2 Name	N/A			N/A	Ramp inside XWalk1?	Yes	N/A	Ramp inside XWalk2?	N/A
Stop Condition-Street 1	N/A				Road Slope (%)	N/A	N/A	Clear Space?	N/A
					Road X Slope (%)	N/A	N/A	Clear Space to XWalk (in)	N/A
				N/A	Any Obstructions?	N/A	N/A	Storm Grate/Utility Hazard?	N/A
		Total Cost: \$	1850.00		Obstruction Type			Storm Grate/Utility Type
