Access Compliance Report

Public Rights-of-Way

(Curb Ramps)

Intersection ID: 15375	Main Street: FUGATE_AV	Cross Street: MONROE_RD	Location: E
ADA ID: 3C5F727664BF	Ramp Type: Para	Initial Pass/Fail: Fail	Overall Compliance: No
Codes/Mitigation Info/Possible Solution		Field Measurements/Component Compliance	
Severity Score: 13.75

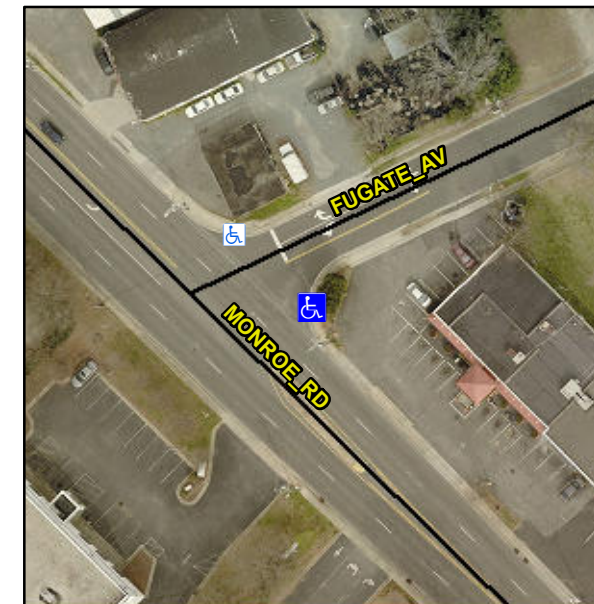
RT RP < 5%

R304.3.2, R304.5.3

Compliance	Description	Data	Compliance	Description	Data
N/A	Ramp Length LT (in)	64.0	N/A	Ramp Length RT (in)	59.0
Yes	Ramp Width LT (in)	48.0	Yes	Ramp Width RT (in)	50.0
No	Ramp Slope LT (%)	9.3	Yes	Ramp Slope RT (%)	3.6
No	Ramp XSlope LT (%)	3.1	Yes	Ramp XSlope RT (%)	2.0
N/A	Landing Length (in)	N/A	N/A	DWS Provided?	N/A
N/A	Landing Width (in)	N/A	N/A	DWS Contrast?	N/A
N/A	Landing Slope (%)	N/A	N/A	DWS Length (in)	N/A
N/A	Landing X Slope (%)	N/A	N/A	DWS Full Width?	N/A
N/A	Landing Curb? (Y/N)	N/A	N/A	DWS Offset (in)	N/A
N/A	Shared Landing?	N/A			
N/A	Gutter Ponding?	N/A	N/A	Gutter Slope (%)	N/A
N/A	Gutter Lip Ht (in)	N/A	N/A	Gutter X Slope (%)	N/A
N/A	Painted X Walk1?	No	N/A	Painted X Walk2?	N/A
	X Walk 1 Direction	To NW		X Walk 2 Direction	N/A
N/A	X Walk 1 Width (in)	N/A	N/A	X Walk 2 Width (in)	N/A
	X Walk 1 Slope (%)	1.3		X Walk 2 Slope (%)	N/A
	X Walk 1 X Slope (%)	0.9		X Walk 2 X Slope (%)	N/A
N/A	Ramp inside XWalk1?	N/A	N/A	Ramp inside XWalk2?	N/A

Road Slope (%)	N/A	N/A	Clear Space?	N/A
	Road X Slope (%)	N/A	N/A	Clear Space to XWalk (in)	N/A
N/A	Any Obstructions?	N/A	N/A	Storm Grate/Utility Hazard?	N/A
	Obstruction Type			Storm Grate/Utility Type	
		N/A			N/A
			Yes	Surface Condition? (G/P)	Good
			N/A	Curb Slope (%)	14.1

Possible Solutions:

Remove & Replace Entire Ramp.
