Access Compliance Report

Public Rights-of-Way (Curb Ramps)

Intersection ID: 53147	Main Street: ACHIEVEMENT_LN	Cross Street: NEW_RENAISSANCE_WY	Location: SW
ADA ID: 3C656EEC4D93	Ramp Type: Directional1	Initial Pass/Fail: Fail	Overall Compliance: No
		Severity Score: 1.25

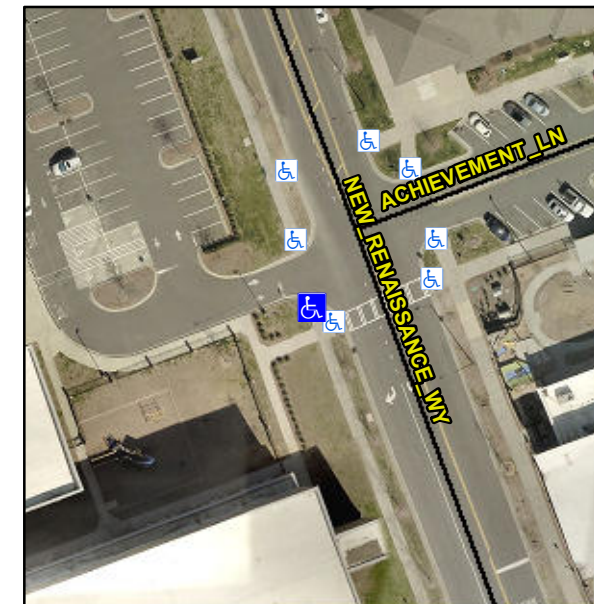
Compliance	Description	Data	Compliance	Description	Data
N/A	Ramp Length (in)	72.0	N/A	Grade Break?	N/A
Yes	Ramp Width (in)	70.0	N/A	Grade Break Slope (%)	0.0
Yes	Ramp Slope (%)	8.2	N/A	Grade Break XSlope (%)	0.0
No	Ramp XSlope (%)	4.3			
N/A	Flare Type LT	N/A	N/A	Flare Type RT	N/A
N/A	Flare Slope LT (%)	N/A	N/A	Flare Slope RT (%)	0.0
N/A	Flare Traversable LT?	N/A	N/A	Flare Traversable RT?	N/A
N/A	Landing Length (in)	0.0	N/A	DWS Provided?	N/A
N/A	Landing Width (in)	0.0	N/A	DWS Contrast?	N/A
N/A	Landing Slope (%)	0.0	N/A	DWS Length (in)	N/A
N/A	Landing X Slope (%)	0.0	N/A	DWS Full Width?	N/A
N/A	Landing Curb? (Y/N)	N/A	N/A	DWS Offset LT (in)	N/A
N/A	Shared Landing?	N/A	N/A	DWS Offset RT (in)	N/A
N/A	Gutter Ponding?	0.0	N/A	Gutter Slope (%)	N/A
N/A	Gutter Lip Ht (in)	0.0	N/A	Gutter X Slope (%)	N/A
N/A	Painted X Walk1?	No		Road Slope (%)	1.1
	X Walk 1 Direction	To NW		Road X Slope (%)	0.8
	X Walk 1 Width (in)	N/A		Clear Space?	N/A

X Walk 1 Slope (%)	1.1	N/A	Clear Space to XWalk (in)	N/A
	X Walk 1 X Slope (%)	0.8	N/A	Storm Grate/Utility Hazard?	N/A
N/A	Ramp inside XWalk1?	N/A		Storm Grate/Utility Type	
N/A	Any Obstructions?	N/A			N/A
	Obstruction Type		Yes	Surface Condition? (G/P)	Good
			N/A	Curb Slope (%)	1.7

Possible Solutions:

Remove & Replace Entire Ramp.
