Access Compliance Report

Public Rights-of-Way

(Curb Ramps)

Intersection ID: 49151	Main Street: DACAVIN_DR	Cross Street: VIDAL_LN	Location: SW
ADA ID: 3C6CE18918D8	Ramp Type: BlendTrans2	Initial Pass/Fail: Fail	Overall Compliance: No
			Severity Score: 33.75

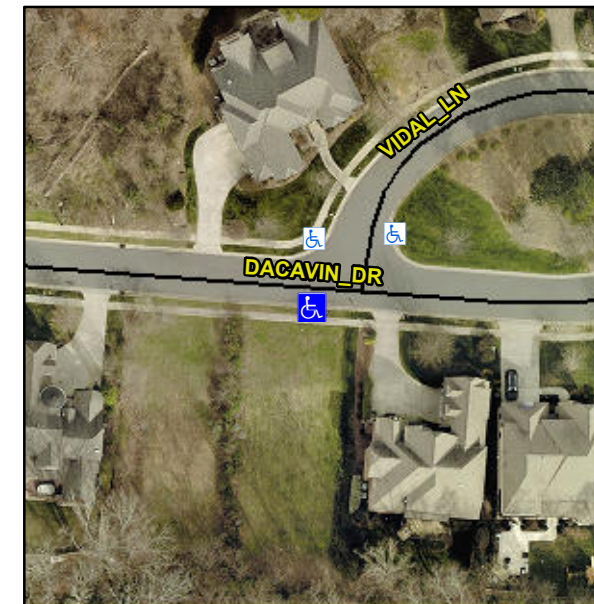
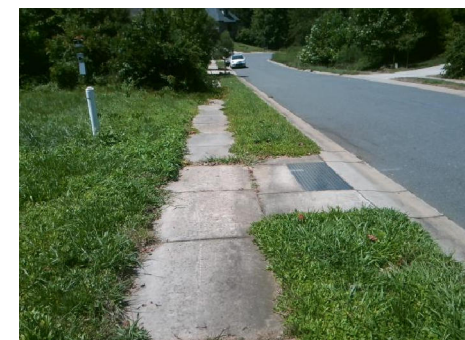
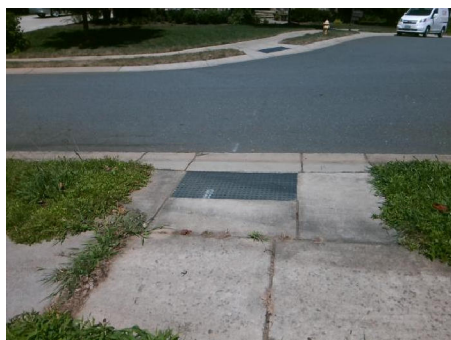
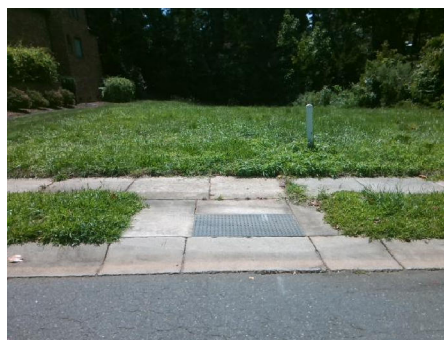
Not Found, R304.5.1, R304.5.3

Compliance	Description	Data	Compliance	Description	Data
N/A	Ramp Length (in)	93.0	Yes	BlendTrans Slope (%)	4.2
No	Ramp Width (in)	47.5	No	BlendTrans XSlope (%)	10.6
N/A	Flare Type LT	N/A	N/A	Flare Type RT	N/A
N/A	Flare Slope LT (%)	N/A	N/A	Flare Slope RT (%)	N/A
N/A	Flare Traversable LT?	N/A	N/A	Flare Traversable RT?	N/A
N/A	Landing Length (in)	N/A	N/A	DWS Provided?	N/A
N/A	Landing Width (in)	N/A	N/A	DWS Contrast?	N/A
N/A	Landing Slope (%)	N/A	N/A	DWS Length (in)	N/A
N/A	Landing X Slope (%)	N/A	N/A	DWS Full Width?	N/A
N/A	Landing Curb? (Y/N)	N/A	N/A	DWS Offset (in)	N/A
N/A	Shared Landing?	N/A			
N/A	Gutter Ponding?	N/A	N/A	Gutter Slope (%)	N/A
N/A	Gutter Lip Ht (in)	N/A	N/A	Gutter X Slope (%)	N/A
N/A	Painted X Walk1?	No	N/A	Painted X Walk2?	N/A
	X Walk 1 Direction	To N		X Walk 2 Direction	N/A
	X Walk 1 Width (in)	N/A		X Walk 2 Width (in)	N/A
	X Walk 1 Slope (%)	1.6		X Walk 2 Slope (%)	N/A
	X Walk 1 X Slope (%)	11.9		X Walk 2 X Slope (%)	N/A

N/A	Ramp inside XWalk1?	N/A	N/A	Ramp inside XWalk2?	N/A
	Road Slope (%)	11.9		Clear Space?	N/A
	Road X Slope (%)	1.6	N/A	Clear Space to XWalk (in)	N/A
N/A	Any Obstructions?	N/A	N/A	Storm Grate/Utility Hazard?	N/A
	Obstruction Type			Storm Grate/Utility Type	
		N/A			N/A
			Yes	Surface Condition? (G/P)	Good
			No	Curb Slope (%)	9.2

Remove & Replace Curb Ramp With Two New Directional Ramps or Equivalent.
