Access Compliance Report

Public Rights-of-Way

(Curb Ramps)

Intersection ID: 27963	Main Street: FAIR_ISLE_DR	Cross Street: MCGINN'S_TRACE_CT	Location: SW
ADA ID: 3C76C6A13694	Ramp Type: BlendTrans1	Initial Pass/Fail: Fail	Overall Compliance: No
		Severity Score: 25

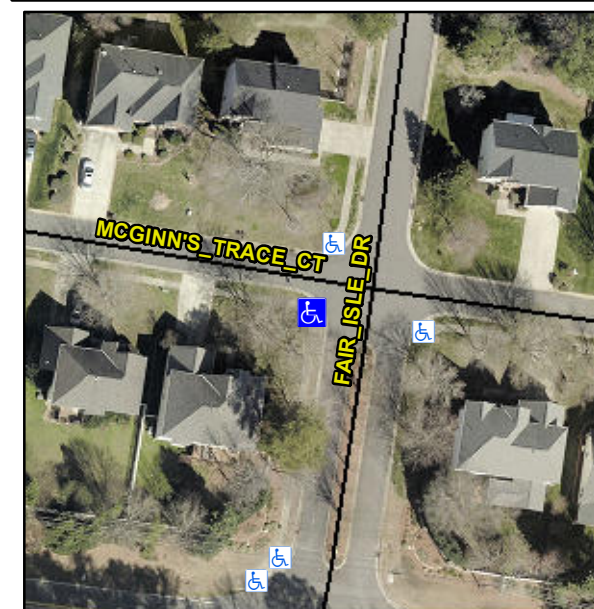
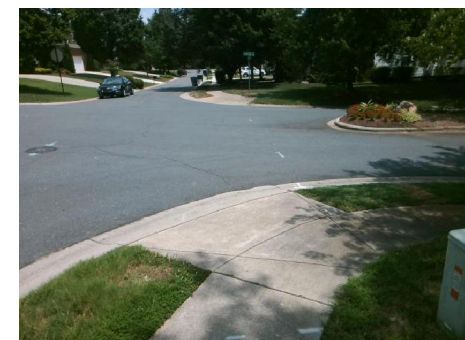
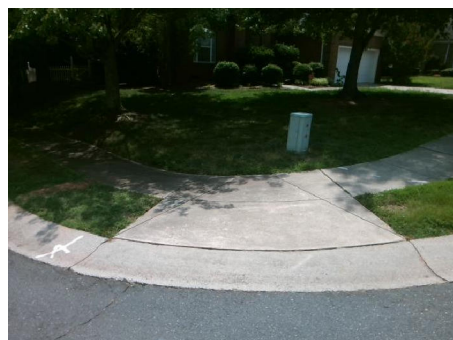
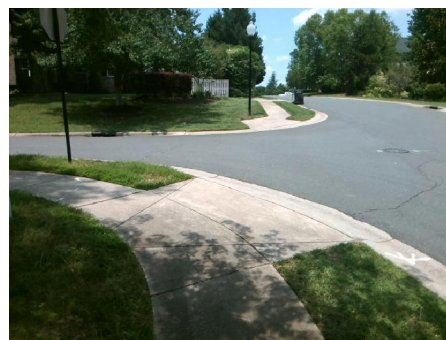
Not Found, R304.5.3

Compliance	Description	Data	Compliance	Description	Data
N/A	Ramp Length (in)	48.0	Yes	BlendTrans Slope (%)	2.1
Yes	Ramp Width (in)	48.0	No	BlendTrans XSlope (%)	9.2
N/A	Flare Type LT	N/A	N/A	Flare Type RT	N/A
N/A	Flare Slope LT (%)	N/A	N/A	Flare Slope RT (%)	N/A
N/A	Flare Traversable LT?	N/A	N/A	Flare Traversable RT?	N/A
N/A	Landing Length (in)	N/A	N/A	DWS Provided?	N/A
N/A	Landing Width (in)	N/A	N/A	DWS Contrast?	N/A
N/A	Landing Slope (%)	N/A	N/A	DWS Length (in)	N/A
N/A	Landing X Slope (%)	N/A	N/A	DWS Full Width?	N/A
N/A	Landing Curb? (Y/N)	N/A	N/A	DWS Offset (in)	N/A
N/A	Shared Landing?	N/A			
N/A	Gutter Ponding?	N/A	N/A	Gutter Slope (%)	N/A
N/A	Gutter Lip Ht (in)	N/A	N/A	Gutter X Slope (%)	N/A
N/A	Painted X Walk1?	No	N/A	Painted X Walk2?	No
	X Walk 1 Direction	To E		X Walk 2 Direction	To N
	X Walk 1 Width (in)	N/A		X Walk 2 Width (in)	N/A
	X Walk 1 Slope (%)	0.2		X Walk 2 Slope (%)	8.2
	X Walk 1 X Slope (%)	10.5		X Walk 2 X Slope (%)	2.7

N/A	Ramp inside XWalk1?	N/A	N/A	Ramp inside XWalk2?	N/A
	Road Slope (%)	8.9		Clear Space?	N/A
	Road X Slope (%)	7.4	N/A	Clear Space to XWalk (in)	N/A
N/A	Any Obstructions?	N/A	N/A	Storm Grate/Utility Hazard?	N/A
	Obstruction Type			Storm Grate/Utility Type	
		N/A			N/A
			Yes	Surface Condition? (G/P)	Good
			No	Curb Slope (%)	10.2

Remove & Replace Curb Ramp With Two New Directional Ramps or Equivalent.

Total Cost: \$ 3200.00
