Access Compliance Report Public Rights-of-Way (Curb Ramps)

Intersection ID: 8746 Main Street: GENERAL_COMMERCE_DR Cross Street: INDUSTRIAL_CENTER_CR Location: N

ADA ID: 3C7C04B9FDCE Ramp Type: Perp Initial Pass/Fail: Fail Overall Compliance: No Severity Score: 12.5

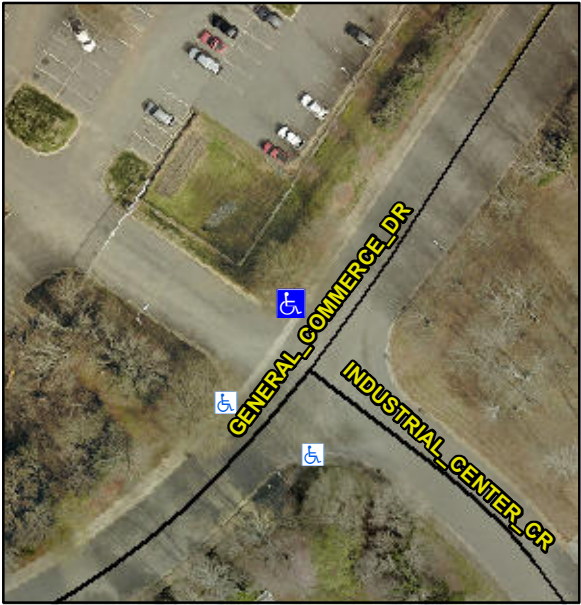
PROW/ADA:
Not Found, R304.2.2

Compliance	Description	Data	Compliance	Description	Data
N/A	Ramp Length (in)	58.0	No	Ramp Slope (%)	8.5
Yes	Ramp Width (in)	48.0	Yes	Ramp XSlope (%)	0.3
N/A	Flare Type LT	N/A	N/A	Flare Type RT	N/A
N/A	Flare Slope LT (%)	N/A	N/A	Flare Slope RT (%)	N/A
N/A	Flare Traversable LT?	N/A	N/A	Flare Traversable RT?	N/A
N/A	Landing Length (in)	N/A	N/A	DWS Provided?	N/A
N/A	Landing Width (in)	N/A	N/A	DWS Contrast?	N/A
N/A	Landing Slope (%)	N/A	N/A	DWS Length (in)	N/A
N/A	Landing X Slope (%)	N/A	N/A	DWS Full Width?	N/A
N/A	Landing Curb? (Y/N)	N/A	N/A	DWS Offset (in)	N/A
N/A	Shared Landing?	N/A			
N/A	Gutter Ponding?	Yes	N/A	Gutter Slope (%)	N/A
N/A	Gutter Lip Ht (in)	N/A	N/A	Gutter X Slope (%)	N/A
N/A	Painted X Walk1?	No	N/A	Painted X Walk2?	N/A
	X Walk 1 Direction	To SW		X Walk 2 Direction	N/A
N/A	X Walk 1 Width (in)	N/A	N/A	X Walk 2 Width (in)	N/A
	X Walk 1 Slope (%)	0.1		X Walk 2 Slope (%)	N/A
	X Walk 1 X Slope (%)	8.1		X Walk 2 X Slope (%)	N/A

N/A	Ramp inside XWalk1?	N/A	N/A	Ramp inside XWalk2?	N/A
	Road Slope (%)	N/A	N/A	Clear Space?	N/A
	Road X Slope (%)	N/A	N/A	Clear Space to XWalk (in)	N/A
N/A	Any Obstructions?	N/A	N/A	Storm Grate/Utility Hazard?	N/A
	Obstruction Type			Storm Grate/Utility Type	
			N/A		N/A
			Yes	Surface Condition? (G/P)	Good

Possible Solutions:
Remove & Replace Entire Ramp.
