Access Compliance Report

Public Rights-of-Way

(Curb Ramps)

Intersection ID: 13780	Main Street: ELIZABETH_AV	Cross Street: N_TORRENCE_ST	Location: N
ADA ID: 3C7EE7075A95	Ramp Type: Perp	Initial Pass/Fail: Fail	Overall Compliance: No
Severity Score: 12.5			
Codes/Mitigation Info/Possible Solution		Field Measurements/Component Compliance

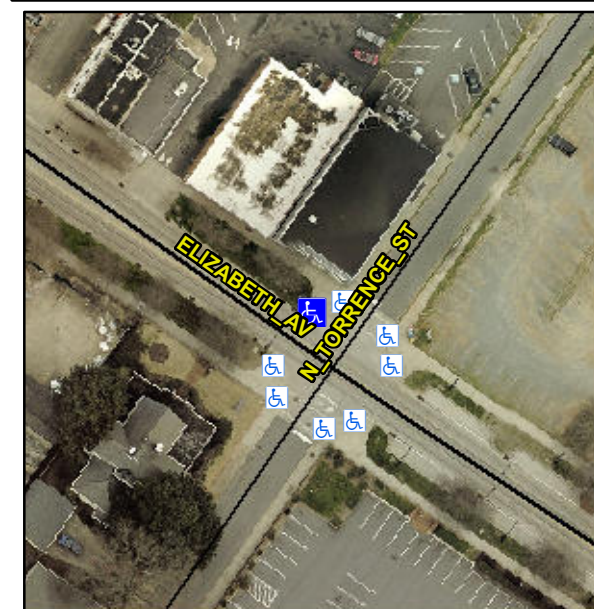
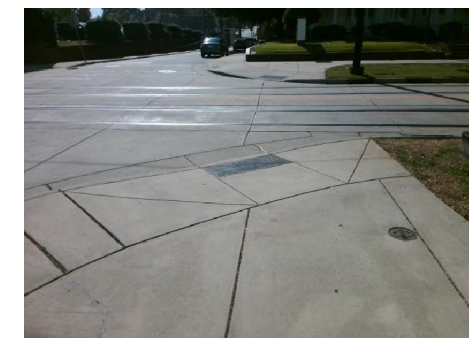
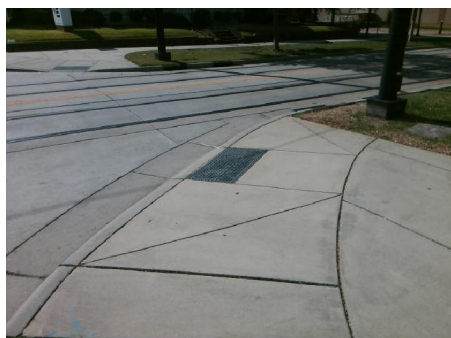
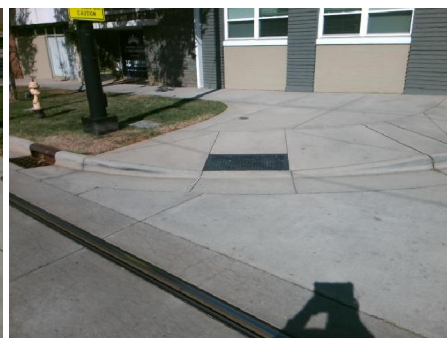
Not Found, R304.2.2

Compliance	Description	Data	Compliance	Description	Data
N/A	Ramp Length (in)	71.0	No	Ramp Slope (%)	8.8
Yes	Ramp Width (in)	48.0	Yes	Ramp XSlope (%)	1.8
N/A	Flare Type LT	N/A	N/A	Flare Type RT	N/A
N/A	Flare Slope LT (%)	N/A	N/A	Flare Slope RT (%)	N/A
N/A	Flare Traversable LT?	N/A	N/A	Flare Traversable RT?	N/A
N/A	Landing Length (in)	N/A	N/A	DWS Provided?	N/A
N/A	Landing Width (in)	N/A	N/A	DWS Contrast?	N/A
N/A	Landing Slope (%)	N/A	N/A	DWS Length (in)	N/A
N/A	Landing X Slope (%)	N/A	N/A	DWS Full Width?	N/A
N/A	Landing Curb? (Y/N)	N/A	N/A	DWS Offset (in)	N/A
N/A	Shared Landing?	N/A			
N/A	Gutter Ponding?	N/A	N/A	Gutter Slope (%)	N/A
N/A	Gutter Lip Ht (in)	N/A	N/A	Gutter X Slope (%)	N/A
N/A	Painted X Walk1?	No	N/A	Painted X Walk2?	N/A
	X Walk 1 Direction	To SW		X Walk 2 Direction	N/A
N/A	X Walk 1 Width (in)	N/A	N/A	X Walk 2 Width (in)	N/A
	X Walk 1 Slope (%)	1.8		X Walk 2 Slope (%)	N/A
	X Walk 1 X Slope (%)	1.2		X Walk 2 X Slope (%)	N/A

N/A	Ramp inside XWalk1?	N/A	N/A	Ramp inside XWalk2?	N/A
	Road Slope (%)	N/A	N/A	Clear Space?	N/A
	Road X Slope (%)	N/A	N/A	Clear Space to XWalk (in)	N/A
N/A	Any Obstructions?	N/A	N/A	Storm Grate/Utility Hazard?	N/A
	Obstruction Type			Storm Grate/Utility Type	
		N/A			N/A
			Yes	Surface Condition? (G/P)	Good

Remove & Replace Entire Ramp.

Total Cost: \$ 1850.00
