Access Compliance Report

Public Rights-of-Way

(Curb Ramps)

Intersection ID: 47644	Main Street: DESHLER MORRIS LN	Cross Street: WESTON WOODS LN	Location:	N
ADA ID: 3C815B72B05B	Ramp Type: Perp	Initial Pass/Fail: Fail	Overall Compliance: No	Severity Score: 21.25
Codes/Mitigation Info/Possible Solution		Field Measurements/Component Compliance

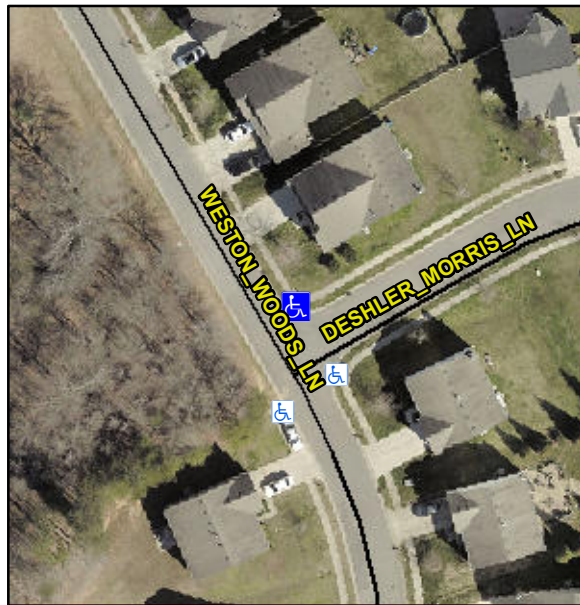
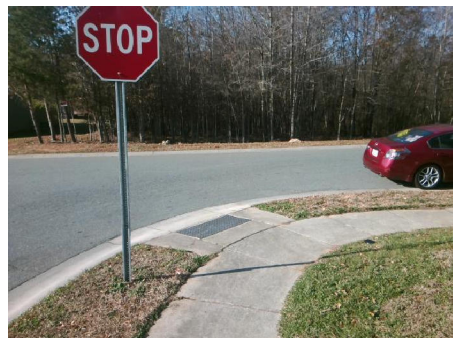
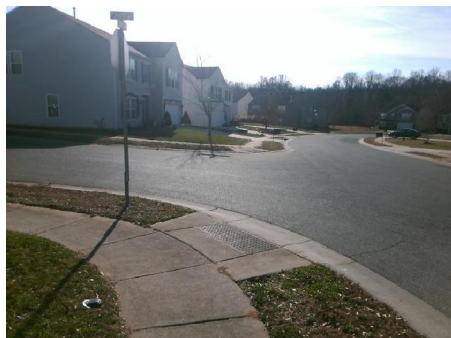
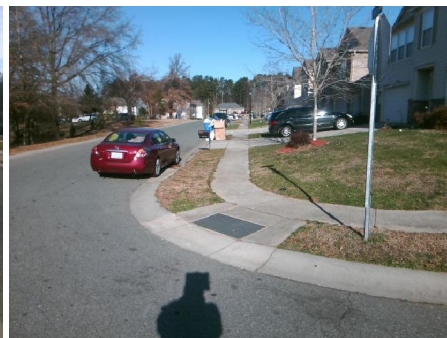
Not Found, R304.5.1, R304.2.2

Compliance	Description	Data	Compliance	Description	Data
N/A	Ramp Length (in)	47.0	No	Ramp Slope (%)	8.6
No	Ramp Width (in)	47.0	Yes	Ramp XSlope (%)	1.6
N/A	Flare Type LT	N/A	N/A	Flare Type RT	N/A
N/A	Flare Slope LT (%)	N/A	N/A	Flare Slope RT (%)	N/A
N/A	Flare Traversable LT?	N/A	N/A	Flare Traversable RT?	N/A
N/A	Landing Length (in)	N/A	N/A	DWS Provided?	N/A
N/A	Landing Width (in)	N/A	N/A	DWS Contrast?	N/A
N/A	Landing Slope (%)	N/A	N/A	DWS Length (in)	N/A
N/A	Landing X Slope (%)	N/A	N/A	DWS Full Width?	N/A
N/A	Landing Curb? (Y/N)	N/A	N/A	DWS Offset (in)	N/A
N/A	Shared Landing?	N/A			
N/A	Gutter Ponding?	N/A	N/A	Gutter Slope (%)	N/A
N/A	Gutter Lip Ht (in)	N/A	N/A	Gutter X Slope (%)	N/A
N/A	Painted X Walk1?	No	N/A	Painted X Walk2?	N/A
	X Walk 1 Direction	To SE		X Walk 2 Direction	N/A
N/A	X Walk 1 Width (in)	N/A	N/A	X Walk 2 Width (in)	N/A
	X Walk 1 Slope (%)	2.6		X Walk 2 Slope (%)	N/A
	X Walk 1 X Slope (%)	1.5		X Walk 2 X Slope (%)	N/A

N/A	Ramp inside XWalk1?	N/A	N/A	Ramp inside XWalk2?	N/A
	Road Slope (%)	N/A	N/A	Clear Space?	N/A
	Road X Slope (%)	N/A	N/A	Clear Space to XWalk (in)	N/A
N/A	Any Obstructions?	N/A	N/A	Storm Grate/Utility Hazard?	N/A
	Obstruction Type			Storm Grate/Utility Type	
		N/A			N/A
			Yes	Surface Condition? (G/P)	Good

Remove & Replace Entire Ramp.

Total Cost: \$ 1850.00
