Access Compliance Report

Public Rights-of-Way

(Curb Ramps)

Intersection ID: 23581	Main Street: BRANDON_FOREST_DR	Cross Street: DRYDEN_LN	Location: SW
ADA ID: 3C859D44B1FA	Ramp Type: PerpDiag	Initial Pass/Fail: Fail	Overall Compliance: No
Codes/Mitigation Info/Possible Solution		Field Measurements/Component Compliance

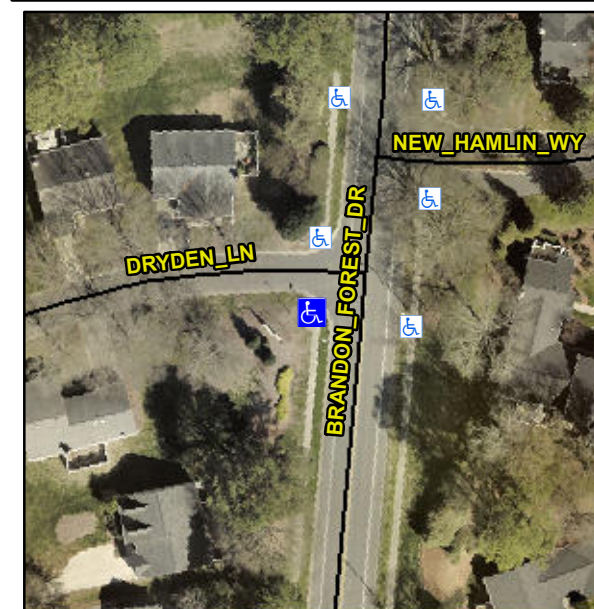
Compliance	Description	Data	Compliance	Description	Data
N/A	Ramp Length (in)	64.0	No	Ramp Slope (%)	9.2
Yes	Ramp Width (in)	49.0	No	Ramp XSlope (%)	2.4
N/A	Flare Type LT	N/A	N/A	Flare Type RT	N/A
N/A	Flare Slope LT (%)	N/A	N/A	Flare Slope RT (%)	N/A
N/A	Flare Traversable LT?	N/A	N/A	Flare Traversable RT?	N/A
N/A	Landing Length (in)	N/A	N/A	DWS Provided?	N/A
N/A	Landing Width (in)	N/A	N/A	DWS Contrast?	N/A
N/A	Landing Slope (%)	N/A	N/A	DWS Length (in)	N/A
N/A	Landing X Slope (%)	N/A	N/A	DWS Full Width?	N/A
N/A	Landing Curb? (Y/N)	N/A	N/A	DWS Offset (in)	N/A
N/A	Shared Landing?	N/A			
N/A	Gutter Ponding?	N/A	N/A	Gutter Slope (%)	N/A
N/A	Gutter Lip Ht (in)	N/A	N/A	Gutter X Slope (%)	N/A
N/A	Painted X Walk1?	No	N/A	Painted X Walk2?	No
	X Walk 1 Direction	To E		X Walk 2 Direction	To N
N/A	X Walk 1 Width (in)	N/A	N/A	X Walk 2 Width (in)	N/A
	X Walk 1 Slope (%)	2.9		X Walk 2 Slope (%)	4.4
	X Walk 1 X Slope (%)	1.1		X Walk 2 X Slope (%)	3.4

N/A	Ramp inside XWalk1?	N/A	N/A	Ramp inside XWalk2?	N/A
	Road Slope (%)	1.5	N/A	Clear Space?	N/A
	Road X Slope (%)	2.5	N/A	Clear Space to XWalk (in)	N/A
N/A	Any Obstructions?	N/A	N/A	Storm Grate/Utility Hazard?	N/A
	Obstruction Type			Storm Grate/Utility Type	
		N/A			N/A
			Yes	Surface Condition? (G/P)	Good

Remove & Replace Curb Ramp With Two New Directional Ramps or Equivalent.

R304.2.2, R304.5.3
