Access Compliance Report

Public Rights-of-Way

(Curb Ramps)

Intersection ID: 18820	Main Street: SEVENTY SEVEN CENTER DR	Cross Street: TYVOLA RD	Location: NW
ADA ID: 3C8BE4DE8359	Ramp Type: PerpDiag	Initial Pass/Fail: Fail	Overall Compliance: No
Severity Score: 12.5			
Codes/Mitigation Info/Possible Solution		Field Measurements/Component Compliance

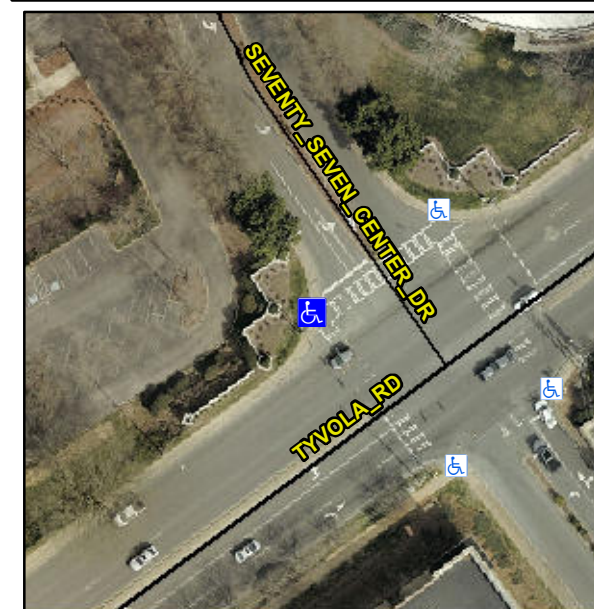
Not Found, R304.5.3

Compliance	Description	Data	Compliance	Description	Data
N/A	Ramp Length (in)	48.0	Yes	Ramp Slope (%)	5.2
Yes	Ramp Width (in)	57.0	No	Ramp XSlope (%)	5.7
N/A	Flare Type LT	N/A	N/A	Flare Type RT	N/A
N/A	Flare Slope LT (%)	N/A	N/A	Flare Slope RT (%)	N/A
N/A	Flare Traversable LT?	N/A	N/A	Flare Traversable RT?	N/A
N/A	Landing Length (in)	N/A	N/A	DWS Provided?	N/A
N/A	Landing Width (in)	N/A	N/A	DWS Contrast?	N/A
N/A	Landing Slope (%)	N/A	N/A	DWS Length (in)	N/A
N/A	Landing X Slope (%)	N/A	N/A	DWS Full Width?	N/A
N/A	Landing Curb? (Y/N)	N/A	N/A	DWS Offset (in)	N/A
N/A	Shared Landing?	N/A			
N/A	Gutter Ponding?	N/A	N/A	Gutter Slope (%)	N/A
N/A	Gutter Lip Ht (in)	N/A	N/A	Gutter X Slope (%)	N/A
N/A	Painted X Walk1?	Yes	N/A	Painted X Walk2?	Yes
	X Walk 1 Direction	To SE		X Walk 2 Direction	To NE
N/A	X Walk 1 Width (in)	77.0	N/A	X Walk 2 Width (in)	95.0
	X Walk 1 Slope (%)	1.2		X Walk 2 Slope (%)	0.4
	X Walk 1 X Slope (%)	0.5		X Walk 2 X Slope (%)	2.2

N/A	Ramp inside XWalk1?	Yes	N/A	Ramp inside XWalk2?	Yes
	Road Slope (%)	2.8	N/A	Clear Space?	N/A
	Road X Slope (%)	1.2	N/A	Clear Space to XWalk (in)	N/A
N/A	Any Obstructions?	N/A	N/A	Storm Grate/Utility Hazard?	N/A
	Obstruction Type			Storm Grate/Utility Type	
		N/A			N/A
		Yes		Surface Condition? (G/P)	Good

Remove & Replace Curb Ramp With Two New Directional Ramps or Equivalent.
