Intersection ID: 23690	Main Street: CRESSIDA_DR	Cross Street: E WESTINGHOUSE BV	Location:	NW
ADA ID: 3C8C7BD0AB05	Ramp Type: PerpDiag	Initial Pass/Fail: Fail	Overall Compliance: No	Severity Score: 13.75

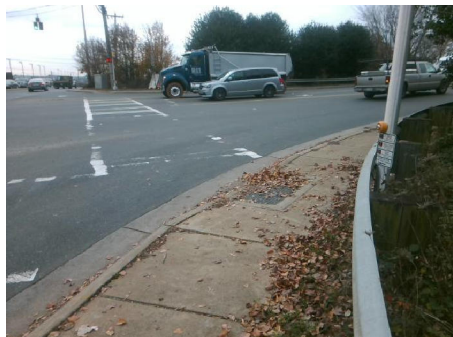
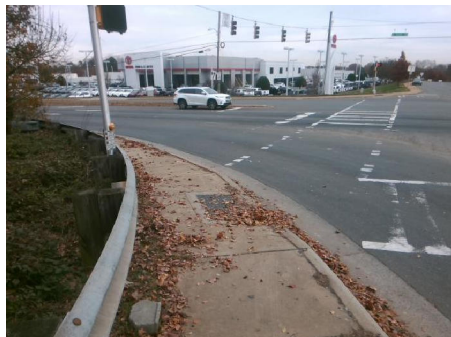
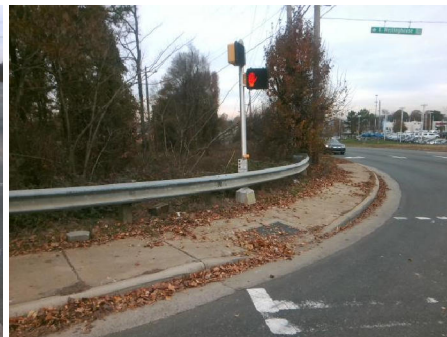
Compliance	Description	Data	Compliance	Description	Data
N/A	Ramp Length (in)	60.0	No	Ramp Slope (%)	9.5
Yes	Ramp Width (in)	48.0	Yes	Ramp XSlope (%)	2.7
N/A	Flare Type LT	N/A	N/A	Flare Type RT	N/A
N/A	Flare Slope LT (%)	N/A	N/A	Flare Slope RT (%)	N/A
N/A	Flare Traversable LT?	N/A	N/A	Flare Traversable RT?	N/A
N/A	Landing Length (in)	N/A	N/A	DWS Provided?	N/A
N/A	Landing Width (in)	N/A	N/A	DWS Contrast?	N/A
N/A	Landing Slope (%)	N/A	N/A	DWS Length (in)	N/A
N/A	Landing X Slope (%)	N/A	N/A	DWS Full Width?	N/A
N/A	Landing Curb? (Y/N)	N/A	N/A	DWS Offset (in)	N/A
N/A	Shared Landing?	N/A			
N/A	Gutter Ponding?	N/A	N/A	Gutter Slope (%)	N/A
N/A	Gutter Lip Ht (in)	N/A	N/A	Gutter X Slope (%)	N/A
N/A	Painted X Walk1?	Yes	N/A	Painted X Walk2?	Yes
	X Walk 1 Direction	To SE		X Walk 2 Direction	To E
N/A	X Walk 1 Width (in)	110.0	N/A	X Walk 2 Width (in)	112.0
	X Walk 1 Slope (%)	2.7		X Walk 2 Slope (%)	2.6
	X Walk 1 X Slope (%)	2.6		X Walk 2 X Slope (%)	4.5

N/A	Ramp inside XWalk1?	Yes	N/A	Ramp inside XWalk2?	Yes
	Road Slope (%)	8.4	N/A	Clear Space?	N/A
	Road X Slope (%)	0.8	N/A	Clear Space to XWalk (in)	N/A
N/A	Any Obstructions?	N/A	N/A	Storm Grate/Utility Hazard?	N/A
	Obstruction Type			Storm Grate/Utility Type	
		N/A			N/A
			Yes	Surface Condition? (G/P)	Good

**Remove & Replace Curb Ramp With Two New Directional Ramps or Equivalent.**
