Access Compliance Report

Public Rights-of-Way

(Curb Ramps)

Intersection ID: 30502	Main Street: ORCHARD_GRASS_CT	Cross Street: STONES_LANDING_ST	Location: SW
ADA ID: 3C930E77CCA7	Ramp Type: PerpDiag	Initial Pass/Fail: Fail	Overall Compliance: No
Severity Score: 35			
Codes/Mitigation Info/Possible Solution		Field Measurements/Component Compliance

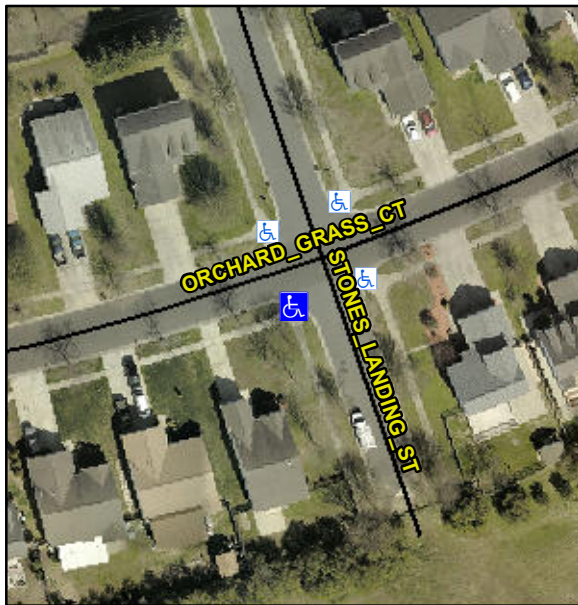
Compliance	Description	Data	Compliance	Description	Data
N/A	Ramp Length (in)	56.0	Yes	Ramp Slope (%)	5.1
No	Ramp Width (in)	31.0	Yes	Ramp XSlope (%)	0.5
N/A	Flare Type LT	N/A	N/A	Flare Type RT	N/A
N/A	Flare Slope LT (%)	N/A	N/A	Flare Slope RT (%)	N/A
N/A	Flare Traversable LT?	N/A	N/A	Flare Traversable RT?	N/A
N/A	Landing Length (in)	N/A	N/A	DWS Provided?	N/A
N/A	Landing Width (in)	N/A	N/A	DWS Contrast?	N/A
N/A	Landing Slope (%)	N/A	N/A	DWS Length (in)	N/A
N/A	Landing X Slope (%)	N/A	N/A	DWS Full Width?	N/A
N/A	Landing Curb? (Y/N)	N/A	N/A	DWS Offset (in)	N/A
N/A	Shared Landing?	N/A			
N/A	Gutter Ponding?	N/A	N/A	Gutter Slope (%)	N/A
N/A	Gutter Lip Ht (in)	N/A	N/A	Gutter X Slope (%)	N/A
N/A	Painted X Walk1?	No	N/A	Painted X Walk2?	No
	X Walk 1 Direction	To E		X Walk 2 Direction	To N
N/A	X Walk 1 Width (in)	N/A	N/A	X Walk 2 Width (in)	N/A
	X Walk 1 Slope (%)	0.9		X Walk 2 Slope (%)	3.4
	X Walk 1 X Slope (%)	1.7		X Walk 2 X Slope (%)	0.5

N/A	Ramp inside XWalk1?	N/A	N/A	Ramp inside XWalk2?	N/A
	Road Slope (%)	1.9	N/A	Clear Space?	N/A
	Road X Slope (%)	2.0	N/A	Clear Space to XWalk (in)	N/A
N/A	Any Obstructions?	N/A	N/A	Storm Grate/Utility Hazard?	N/A
	Obstruction Type			Storm Grate/Utility Type	
		N/A			N/A
			Yes	Surface Condition? (G/P)	Good

Remove & Replace Curb Ramp With Two New Directional Ramps or Equivalent.
